WELSH HIGHLAND HERITAGE

Issue No. 87

NWNGR Fairlies (Part 1)

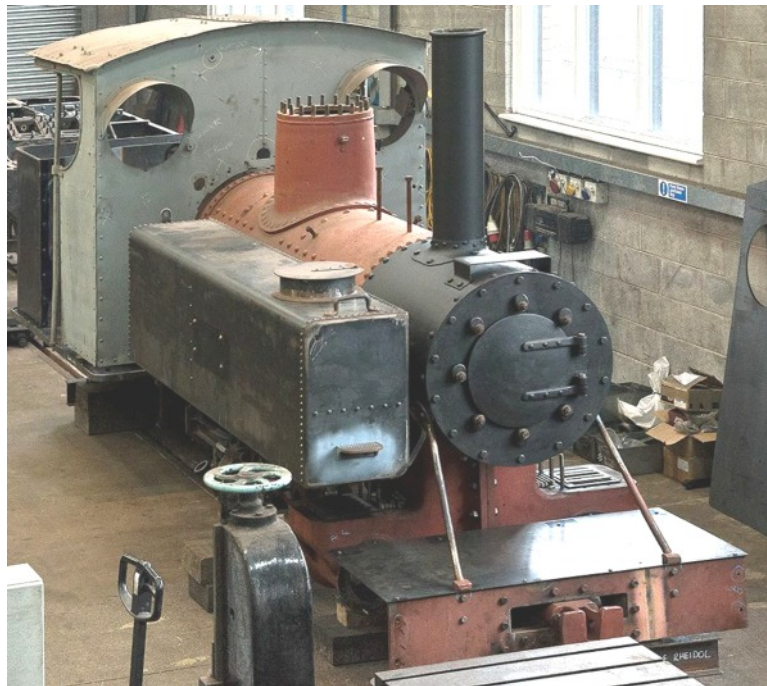
Baldwin 10-12-D no. 794 under restoration at the Vale of Rheidol Railway. When complete, the locomotive will represent the original WHR Baldwin no. 590 - John R Jones.

On a more optimistic note, the Heritage Group made its planned donation to the restoration of the Baldwin 794 as the WHR's 590. Built for the Great War along with many similar machines, after the conflict 794 was sold and exported to India. There it worked on a sugar plantation, carrying the name *Tiger*. Returned from India in about 1985 and now owned by The Imperial War Museum, 794 is on long term loan to the WHHR on the understanding that it is restored to working order. The locomotive will operate under the pseudonym 590, being almost identical to the original WHR locomotive.

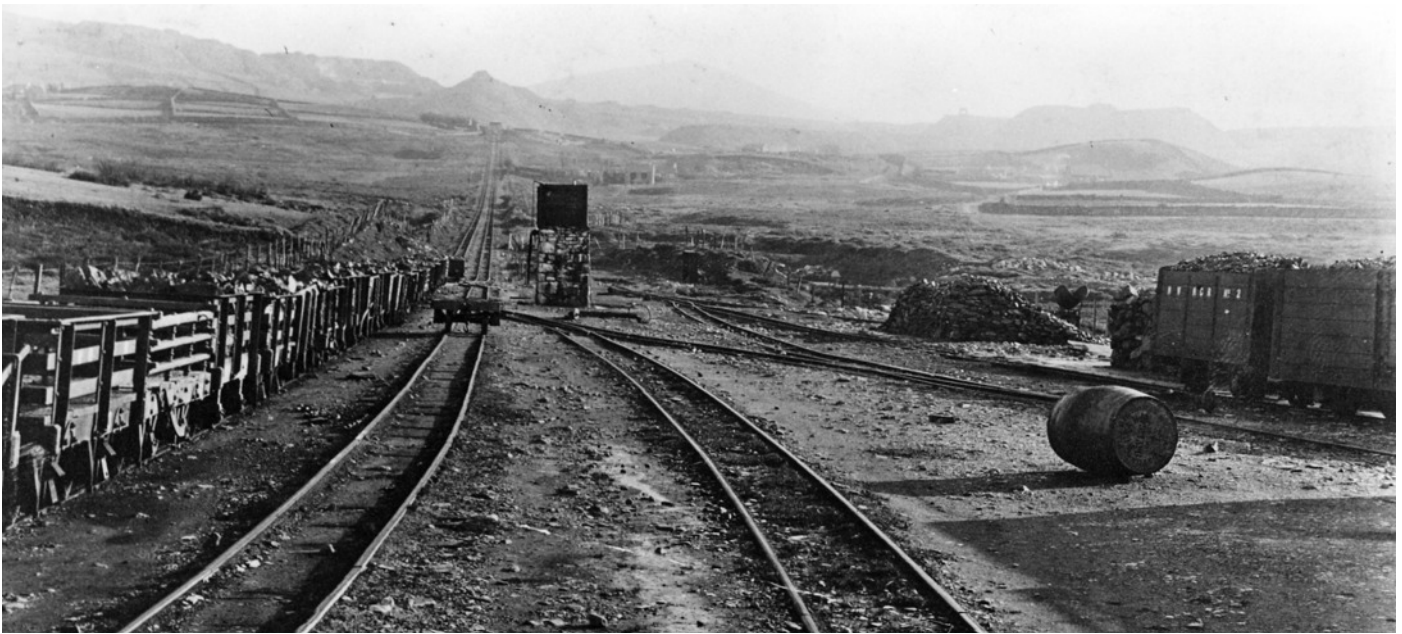
C.J. Keylock Collection - WHR 109

“..then a covered van carrying flour and goods, followed by a large coal carrying wagon and sixteen empty slate wagons”

Turning then to John Hughes account of the days when Mr Tanner was manager (1890-98). One must imagine a train driven by Hugh Williams and stoked by his son Willie Hugh Williams entering the branch at Tryfan Junction. John Hughes describes such a train “it is made up of two carriages – part of one is first class, then a covered van carrying flour and goods, followed by a large coal carrying wagon and sixteen empty slate wagons and finally a guards’ van”.

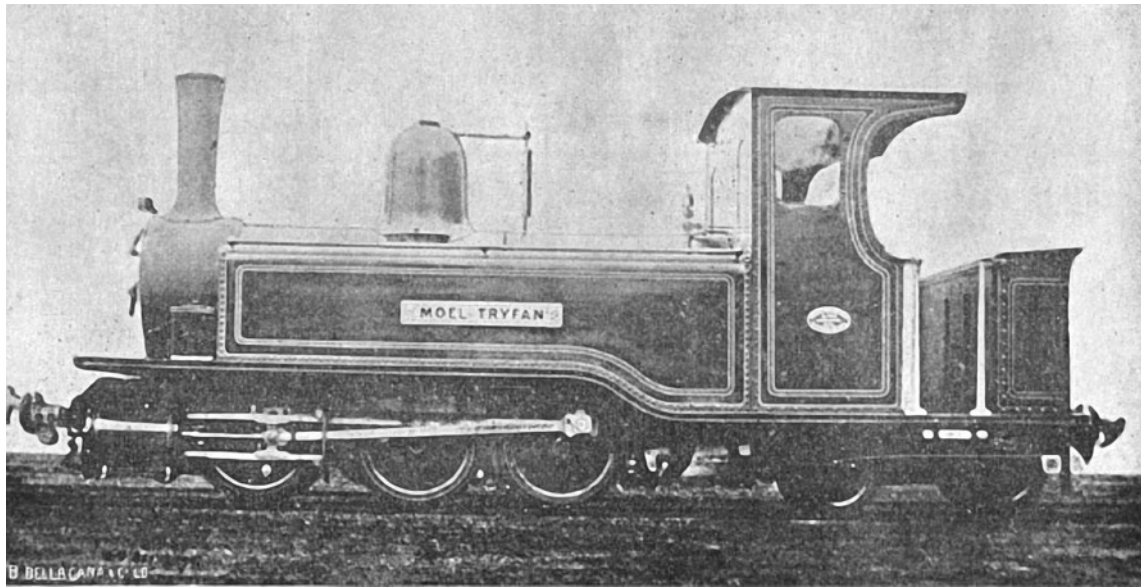
Figure 3) Maker's photo of *Moel Tryfan* - Vulcan Foundry no. 738 - 1876 (Arch 5026)

The makers' photographs, showing each of the two locomotives, are compared in Figures 3 and 4.

Further examination of figure 7 will also show that the painted lining, prominently visible in the maker's photograph (figure 3) had disappeared. Due to image quality it is not possible positively to confirm that this was also the case in figure 6, but it does look as though the lining was missing in that image also. The headlamp prominently visible in figure 7 can also be seen in figure 6, still at the front of the loco despite its change of direction, and the two carriages seen behind the locomotive in figure 6 are there, in the same geographical sequence, in figure 7. Note also in these pre-continuous-brake days the practice of placing many braked passenger vehicles in these trains.

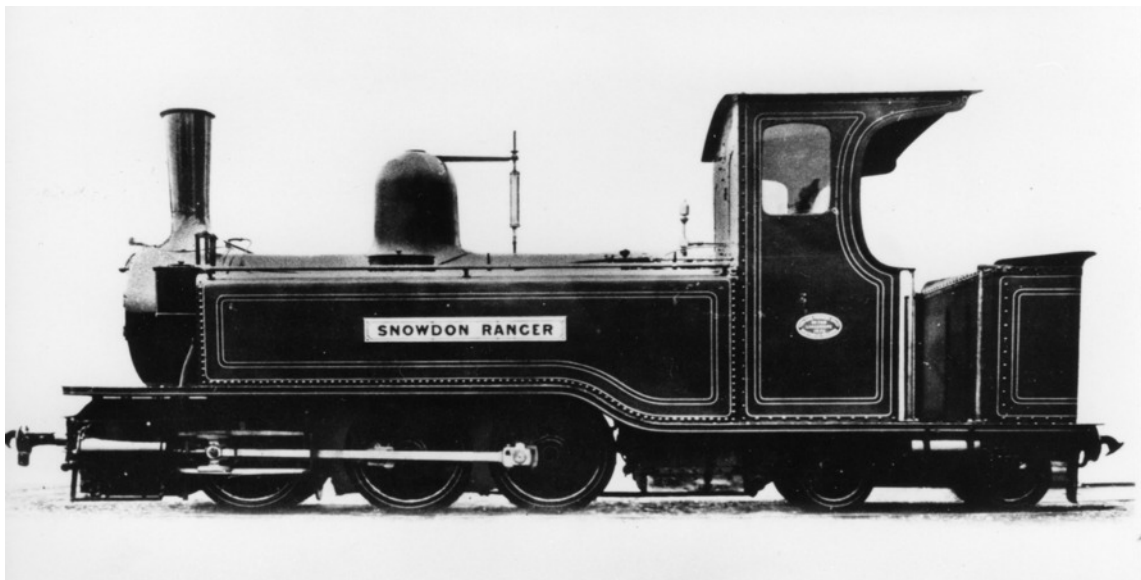
Figure 4) Maker's photo of *Snowdon Ranger* - Vulcan Foundry no. 739 - 1876 (WHR 016)

Both appear to have been painted in their final livery and lining rather than the photographic grey often seen in maker's photos. The definition of the makers plates is poor in the photographs, but in the case of *Snowdon Ranger*, the better photograph of the two, the third digit ('9') of the makers number can be seen to be slightly raised. On *Moel Tryfan*'s plate the numbers appear to be level. The first locomotive built, *Moel Tryfan*, seems to have been closer to the maker's drawings noted above. The changes on *Snowdon Ranger*, relative to the design drawings and to *Moel Tryfan*, imply some additional re-thinking, or perhaps experimentation, as the second locomotive was being built.

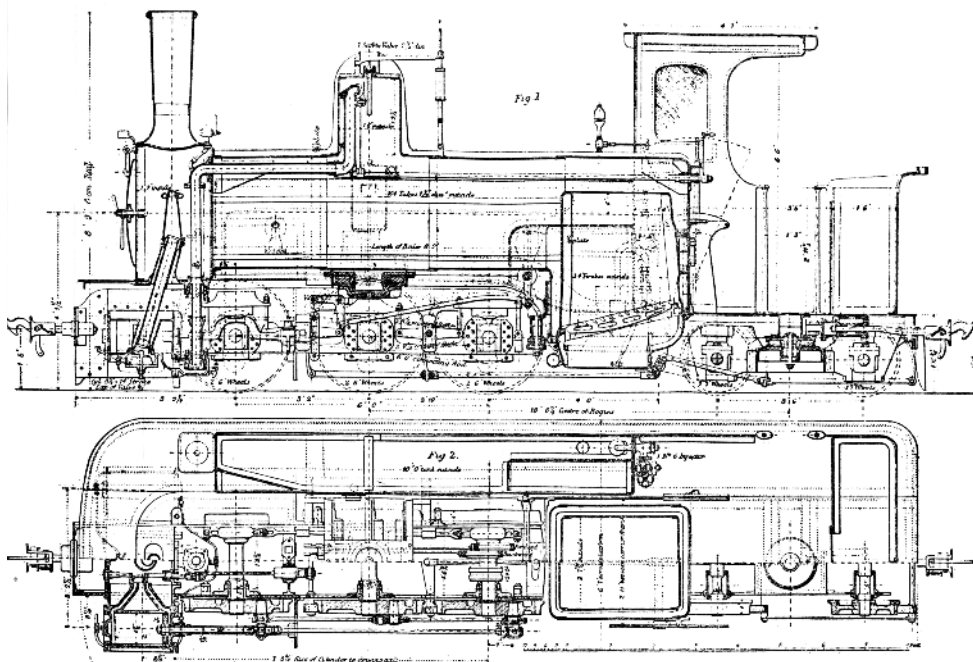
DOUBLE-BOGIE FAIRLIE LOCOMOTIVE FOR THE NORTH WALES NARROW GAUGE RAILWAYS.
CONSTRUCTED BY THE VULCAN FOUNDRY COMPANY, NEWTON-LE-WILLOWS, FROM THE DESIGNS OF MR. G. E. SPOONER, ENGINEER, FORTMADOC.

Figure 5) GA Drawing from *Engineering*, 23rd November, 1877.

The *Engineering* article and diagram from November 1877 (Figure 5) reveal what might appear to be changes made over the first few years. For example, the Chatfield patent fire door arrangement is not shown, having been replaced by a conventional design.

However, such features, noted in the discussion above, cannot be confirmed by the maker's photos, so whether these really were changes or whether the locomotives were built to this latter standard initially is a matter of conjecture. However, as noted above, there was little time between the delivery of the locomotives and the publication of the *Engineering* article (press deadlines should be borne in mind here) to allow such possibly fundamental changes.

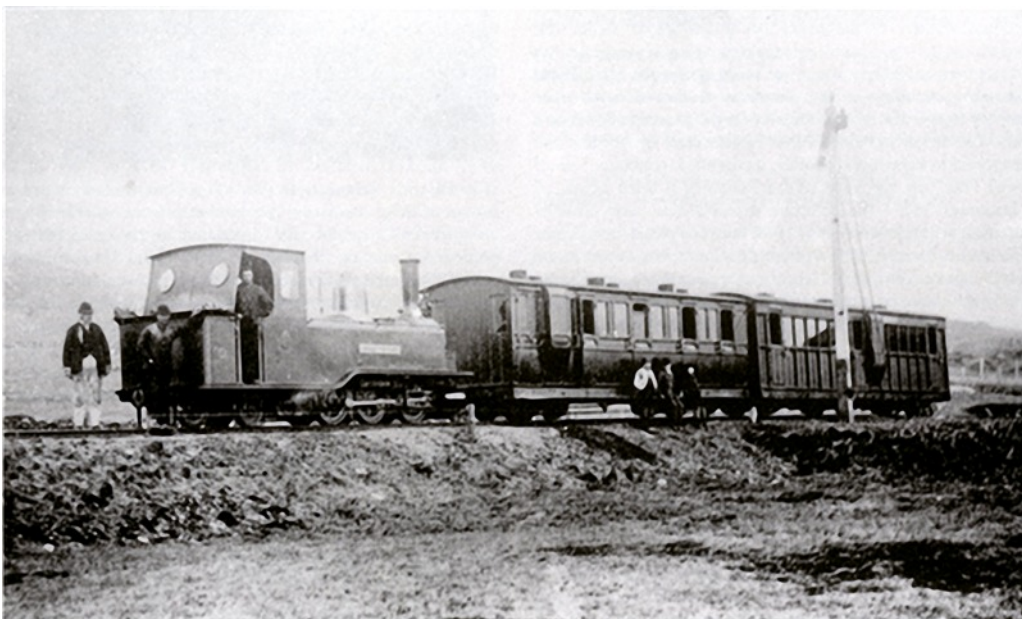
Figure 6) *Moel Tryfan* with a train of two carriages - both Brake Composites, the leading carriage by Ashbury, either no. 1 or 2, the other a Gloucester 'Cleminson', either no. 6 or 7.

The train was waiting to depart a relatively newly-opened Rhyd-ddu, so probably circa 1881/2.

are of *Moel Tryfan*. Quite possibly the earliest of these is shown in figure 6. The photograph was taken at Rhyd-ddu shortly after the opening of the extension from Snowdon Ranger in 1881. A careful examination of the locomotive will indicate two features of interest. First, a steam pipe lubricator, as per the drawing in *Engineering*, had been installed and, second, the maker's plate on the cab side had been replaced by a crest. To be fair, we only see the right-hand side of the locomotive, but it seems entirely reasonable to suppose that the same change was made on the left.

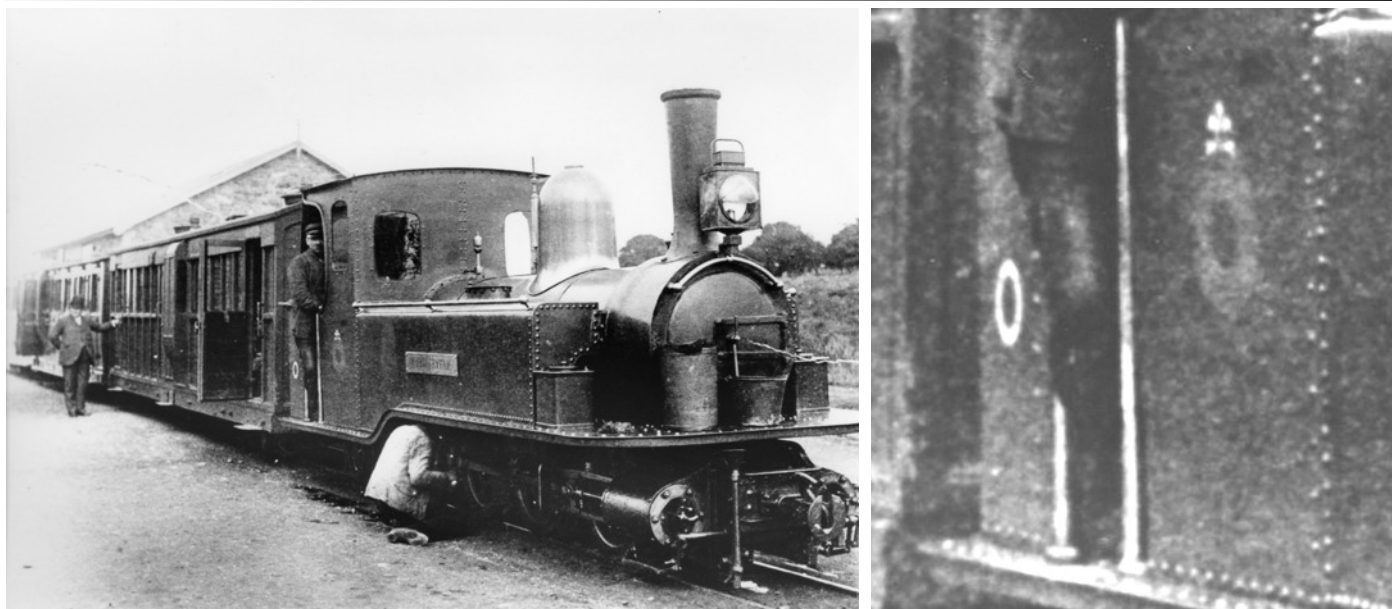
Figure 7 (left) *Moel Tryfan* being prepared for departure from Dinas (Arch 3488)

Figure 8 (right) Enlargement of the cab and bunker sides to show the crests added in lieu of the maker's plates.

If we turn now to figure 7, a close examination of the image will also show the presence of the steam-pipe lubricator and it is more obvious that we also see that the maker's plates(s?) had been replaced by crests. A close up of the crests is seen in figure 8.

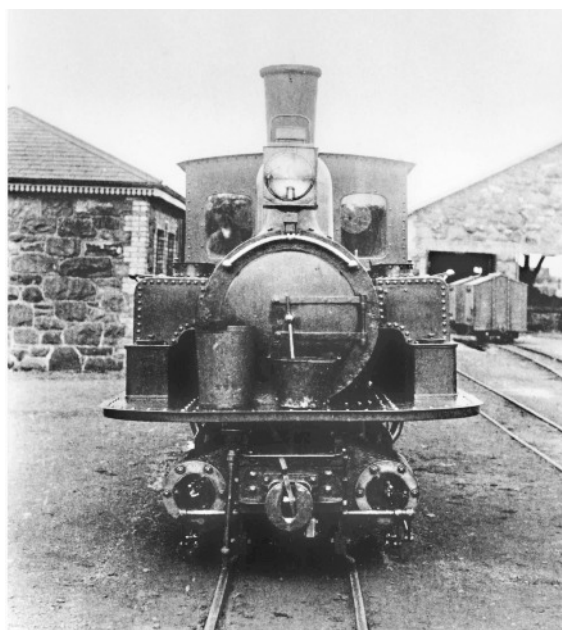
Figure 9) A head-on view of *Moel Tryfan* taken at the same time as figure 7.

Finally, a head-on view of *Moel Tryfan* taken on the same occasion as figure 7 shows the alignment of the sand delivery pipe that had to be filled manually by the fireman while the locomotive was in motion. This will be discussed further in later sections of these notes.

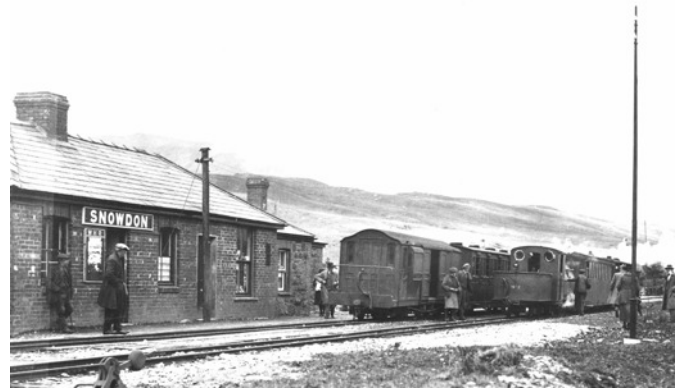
Typically, they show *Palmerston* with a train of FR stock at various locations on the WHR: Dinas Junction (2474), Tryfan Junction (2475), Waenfawr (2476) and Snowdon (2477). Here at Snowdon (the name had not yet been changed to South Snowdon) we see *Prince* on a south-bound train comprising principally Welsh Highland stock. A close examination of the image shows *Prince* to be fitted with chopper couplings and we can see that the one clearly visible item of WHR stock, an Ashbury 'Corridor' had not been cut down. If we accept that the date was 1923, we

can further deduce that any stock marshalled behind *Prince* had to be selected from the vehicles temporarily dual-braked at the start of Welsh Highland operation. This tells us that the Ashbury 'Corridor' was, in fact, NWNCR no. 10. Two other passenger vehicles were dual-braked; the Observation Car (Gladstone) and Pickering Brake Composite no. 4 (later WHR. no. 8). However, it is clear from WHHG 16 that *Prince's* train did not include the Pickering, but instead, one of the 4-wheel brake vans, either an F.R. Van (possibly the dual-braked Van No. 5, today's No. 6) or the dual-braked WHR van (Van No. 4), both derived by modifying Type 3 F.R. Quarrymen's Carriages. The carriage between the 'Corridor' and the Van would have been the Gladstone, and there is just enough of the vehicle visible to confirm this identification.

WHHG 16 is one of the series of Topical Press images taken in 1923. These were Topical references 2474 to 2477 (in our collection as WHHG 9, WHR 164, WHR 159 and WHHG 16 respectively). We also have WHHG 3 which appears to be one of the series but for which there is no positive indication of a Topical reference number.

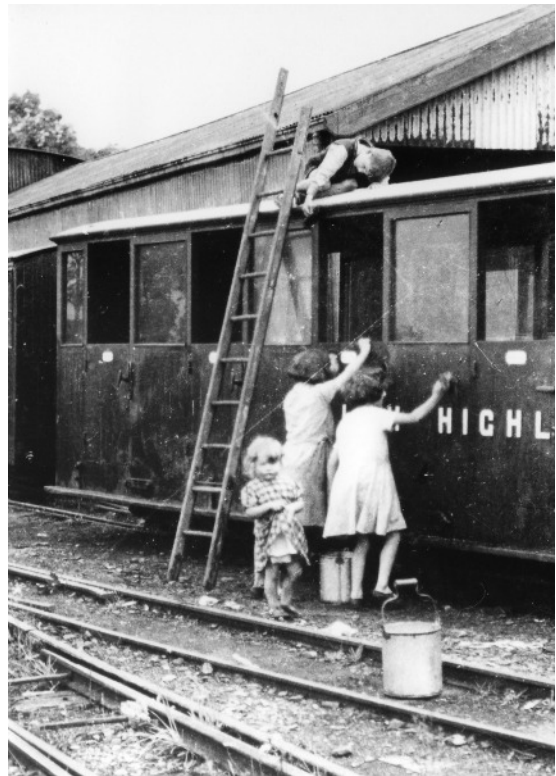
WHR 183

First, WHR 183. It seems from this photograph that volunteer labour is not the sole prerogative of 'modern' heritage railways. This is one of a series of four photographs from the late Bill Rear's collection (WHR 180 to 183) showing Hugh Roberts' children hard at work in 1936 cleaning Ashbury semi-glazed 'Summer' no. 26. It would seem that no main-line train was expected as the ladder would otherwise have represented a significant Health and Safety issue. The carriage was parked close to the crossover carrying the engine shed road from the carriage siding over the main line.

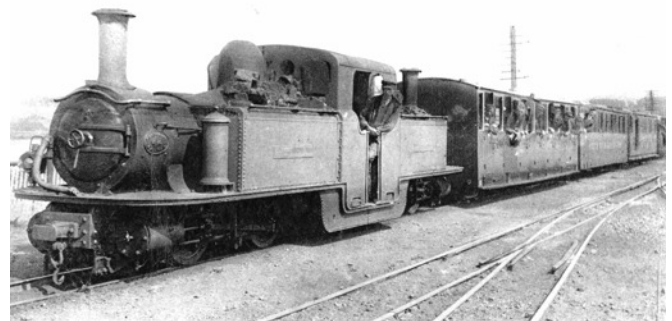
WHHG 37 is a very interesting photograph. It shows the FR double-Fairlie *Merddin Emrys* with a train of Welsh Highland stock about to enter the cross-town link at Portmadoc Harbour. The train comprised: Ashbury semi-glazed 'Summer' No. 26 (? - the image is not entirely clear);

Ashbury 'Corridor' no. 25; one of the Pickering Brake Composite carriages. There appears to have been another locomotive (one of the Englands) behind the Pickering, but the image does not allow this to be properly identified.
