WELSH HIGHLAND HERITAGE

Issue No. 96

The WHR Centenary - and more

Signalling Dinas Junction

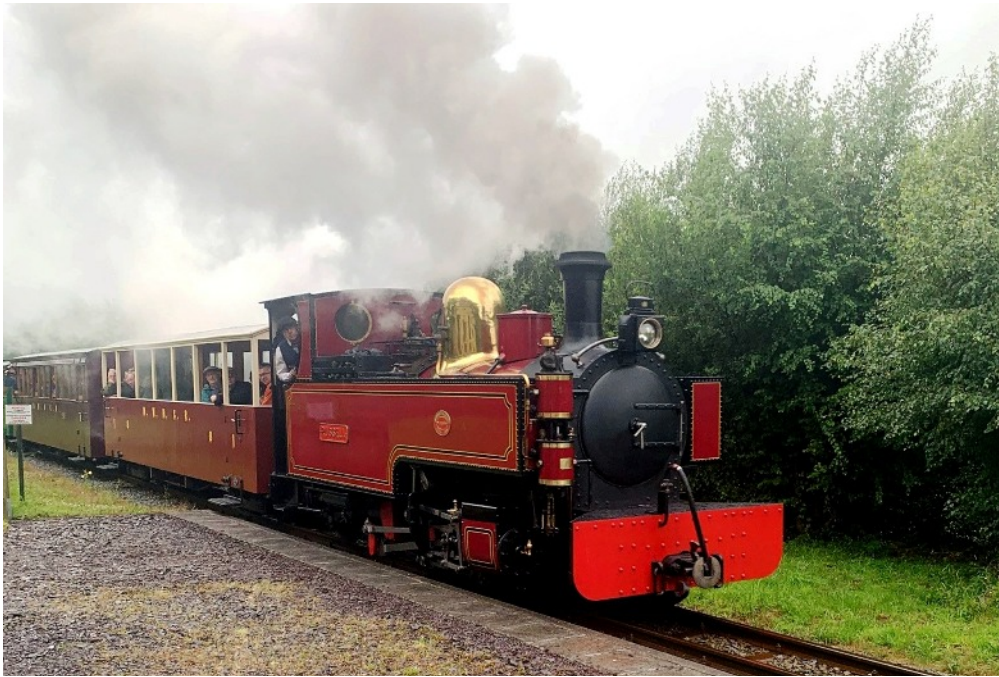
Russell arrives at Tryfan Junction, facing the 'correct' way, with a train of NWNGR stock. Behind the locomotive, we see the Observation Car (No. 8) and then a replica of Ashbury 'Corridor' (No. 9). The flash of green beyond is from the restored Buffet Car, originally NWNGR No. 10. The train was completed by the new replica Pickering Brake Composite - Photo by Peter Roughley - July 2022.

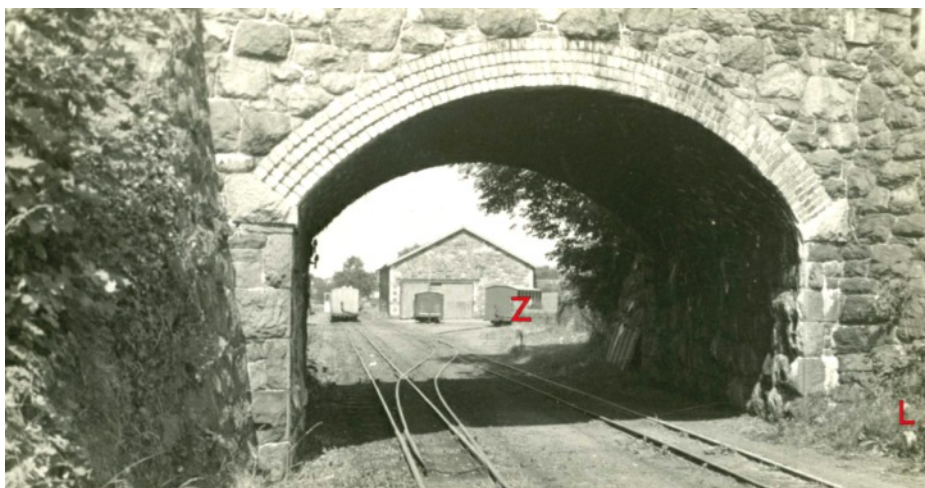
Figure 7.

Another view looking north, this time through the road over bridge, showing the complete cross-over installation.

WHR 074

WHR 074 shows the approach to the platform with hand lever L visible to the right. Of note, the rodding between L and the points as well as H and J is not visible. I contend that these post-1923 rodding runs used the old McK&H channels for the disc wire in the case of L, although at the station end of the crossover, it is not so clear-cut. Looking closely at WHR 063, there is an easily distinguished line M from the prominent sleepers to the left, heading towards O and in the case of J when the levers were changed in 1911 the rod was, perhaps, run through the same channel as the wire to the disc controlling exit from the yard/entry to the Long Siding. Perhaps the longer sleepers are for the rail joint in this area.

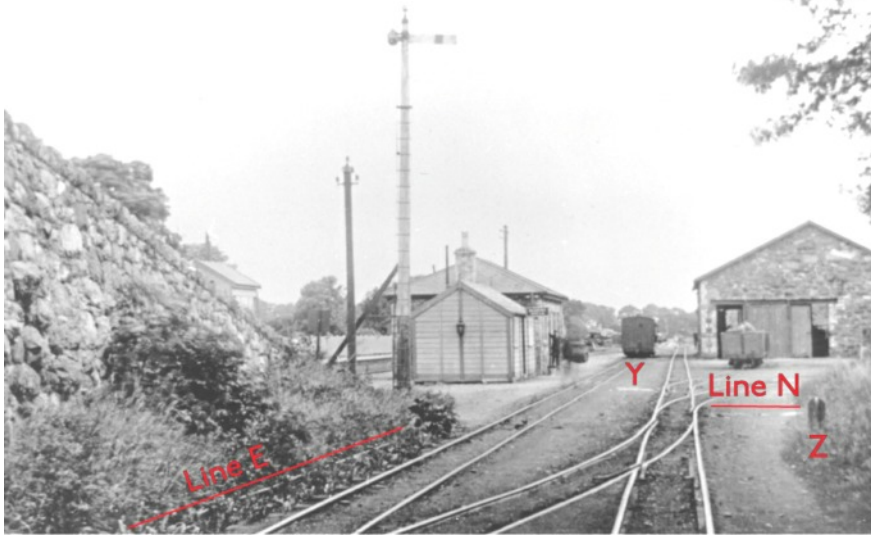
Figure 8.

A similar view to WHR 074 but with the camera located under the bridge.

WHR 137

In WHR 137 (Figure 8), fresh ballast is visible at Y as well as the LNWR boundary post at Z. This boundary post features in a lot of pictures from this angle, and for a long time I thought it was a signal or a gong: neither explanation gave enough reason for it to still be visible in 1930s photographs. Of interest is the continuation of Line E from WHR 014, though only a single rod as the far end of the crossover in this view marked the northern limit of the signal box’s point control. Line N also appears in several photographs, and apparently was a slate-covered trench, which ties in with the changes to the hand levers. The combination of WHR 063 and WHR 137 is the key to understanding the signalling installation, but sadly much can only be inferred and not stated with absolute certainty: there may be other interpretations, and I would welcome discussion.

WHR 137 is one of the few photographs of Dinas with the signalling installed, but precious little is actually on view! However, looking very closely indeed at Line E in WHR

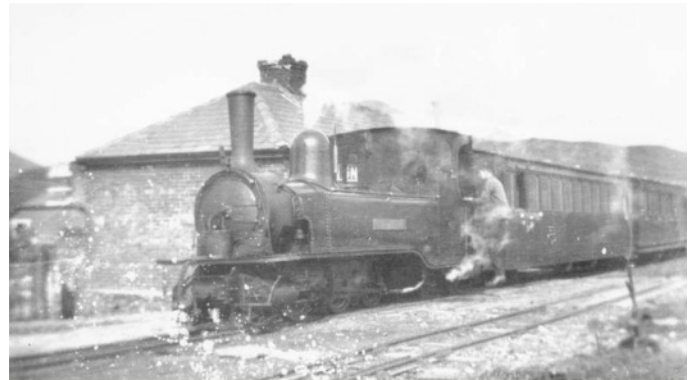
Moel Tryfan recently arrived at Snowdon station. The photo was taken by C.R. Clinker and we have it dated to August 1922 - LGRP 9075 - ARCH 3307

The locomotive, it will be seen, carried no built-in sand boxes but instead sported a metal bucket on the front buffer beam, the bucket handle was hooked over the smoke box door handles, carrying sand should manual sanding have been required. The wire stays apparently fitted circa 1909, discussed in Part 4 of these notes, were still to be seen in Arch 3307. No doubt these were installed for the benefit of crews engaged in manual sanding. There was a patch fitted to the lower rear part of the smoke box and a patch had appeared on the side tank, low down in front of the nameplate.

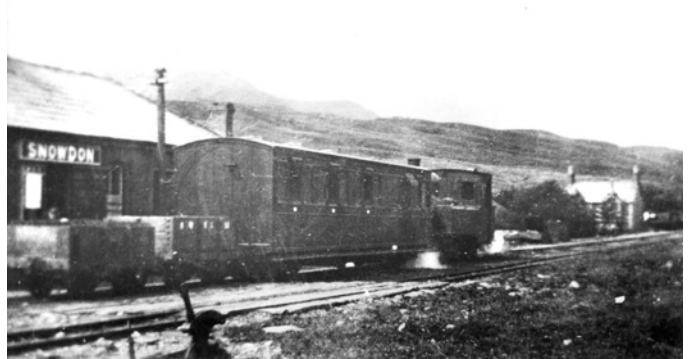
Moel Tryfan with a short train comprising a Pickering brake and two small wooden wagons, one still inscribed "NWNG 58" C.R. Clinker - LGRP 9077 - August 1922 - Arch 3308

In this scene, contemporary with the previous image, we see more clearly that the station still carried the name Snowdon. Regrettably, perhaps, we can determine little from the locomotive other than confirmation of the 'missing' sand boxes.

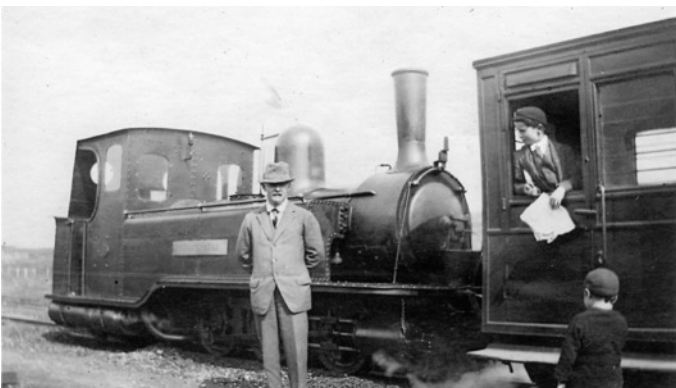
*Moel Tryfan, coupled to a Pickering brake, appear to stand ready to depart Snowdon for Dinas Junction
- Arch 4893.*

The next picture, Arch 4893, presents us with a considerable quandary. The image quality is good, details can readily be determined and, this is potentially important, the sun was shining. However, we have no documented evidence as to the source or the date of this image. So what can we see?

The locomotive was still facing bunker-first towards Dinas. As we shall see in later parts of these notes, this locomotive was turned to run chimney-first towards Dinas more or less immediately the Portmadoc Cross-Town Link was opened, allowing access to the Boston Lodge turntable. Therefore we can deduce this image was taken before mid-May 1923.

At first glance, the shadows cast by the locomotive and the gent posing for the camera would appear to indicate that the sun was aligned, more-or-less, with the track direction. However, a more detailed examination, specifically of the shadow cast by the whistle onto the cab front, suggests otherwise. There are two whistle 'shadows' but the more obvious one, to the left, appears to be a reflection in the cab front. The direct whistle shadow is aligned approximately with the whistle itself. The 'elbow' in the shadow below the physical right-angle bend in the whistle supply pipe gives a good indication of the sun's elevation. It is qualitatively clear that the sun had passed true alignment with the track and had moved somewhat to the west.

The track bearing adjacent to the station building was 156.5 deg. Today, the track has been moved some significant distance to the east. From details seen on the locomotive, we can deduce that the camera sight-line was oriented about 30 degrees to the track centre line. That is to say at 186.5 degrees. However, the shadow cast by the sun can be seen to the left of the whistle, so the sun was not yet fully behind the cameraman. Precise measurements are difficult, but I assess the sun to have been between 5 and 10 degrees less removed from the track centre line, giving a sun azimuth range between 176.5 degrees and 181.5 degrees, that is either side of due south.

This azimuth range, at this longitude, indicates a time range between 12:55 and 13:25 BST. Now the big leap! Were services adhering to the timetable? In 1922 there were departures at 10:40, 13:50, 15:55 and 18:40. However, over the first half of 1923 there were departures at 10:50, 13:00, 15:55, 18:30 and 20:45. If our sun-derived time range is correct, if the timetable was being followed, and if this was an imminent departure, the inevitable conclusion is that the photograph was more probably taken in 1923, before the middle of May, and not during 1922 after the opening in July. Given time, and much more careful analysis, the whistle shadow should yield a sun elevation angle which potentially would pinpoint the actual date.

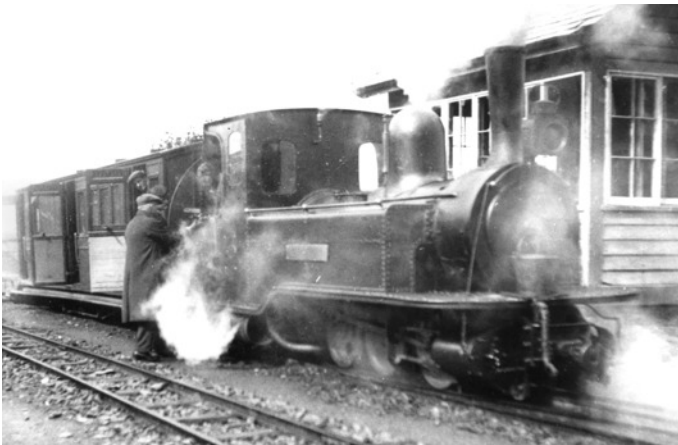
***Moel Tryfan* with short train at Tryfan Junction
Ken Nunn - 15th May 1923 - LCGB 3517
WHHG 07 - Arch 0276**

We are, apparently, spared date ‘uncertainties’ with the final three photographs in this part of these notes. They were, it is recorded, taken by Ken Nunn on 15th May 1923 and sit in the Archive as the last three images that show the locomotive before being reoriented from “the NWNGR way” and, later, cut down. The locomotive details are very much as seen in Arch 4893 earlier but, given the clear view of the front of the locomotive, we can confirm that it was still air-braked.

The Archive notes suggest that this train was the 09:45 service from Dinas to Snowdon. The timetables do show an 09:45 Dinas departure, arriving at Tryfan Junction at 09:57 and Waenfawr at 10:08. Nunn photographed the train at Tryfan Junction (Arch 0276) and at Waenfawr (Arch 3136 and 3181).

In the Tryfan Junction photograph above we can see hints of sunshine, note the shadows cast by window fittings on the inside of the open doors on the Pickering, but determination of the sun’s azimuth is problematic.

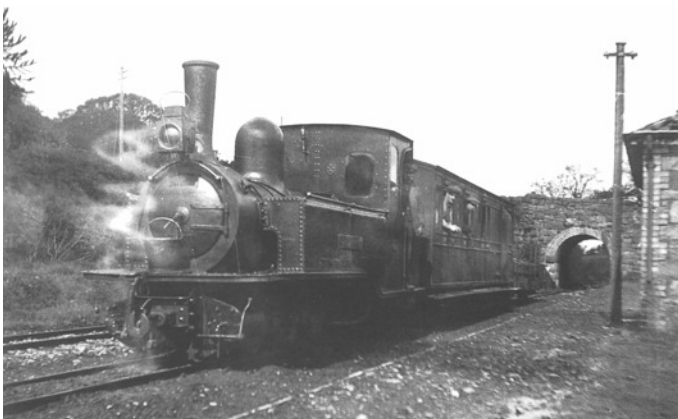
**Ken Nunn’s train arriving at Waenfawr - 15th May 1923
LCGB 3518 (?) - Arch 3136(2)**

However, in Arch 3136 we have a somewhat more clear set of sun shadows that can be measured with reasonable

accuracy. Our friend the whistle shadow is again visible but more clearly we can see the shadow cast by the telegraph pole standing outside the station building.

Again, knowing the track bearing at this point on the original railway, 124.8 degrees, and noting that the photograph was taken before the sun reached alignment with that track bearing (the telephone pole shadow was pointing towards the track) we can deduce that the sun’s azimuth was 107.8 degrees. On this date, that azimuth indicates the time to have been 09:35 BST.

This is interesting as this indicates that the photograph was taken 10 minutes before the scheduled service was due to depart Dinas.

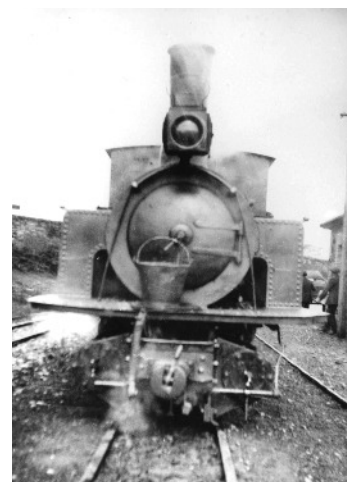
A head-on view of *Moel Tryfan* at Waenfawr, fully contemporary with Arch 3136.

15th May 1923 - LCGB 3519 - Arch 3181

This final view from Nunn’s set gives a very nice head-on view of the locomotive after stopping at Waenfawr, perhaps for the last time in this configuration? Next time, turning the locomotive and operations ahead of its being ‘trimmed’.

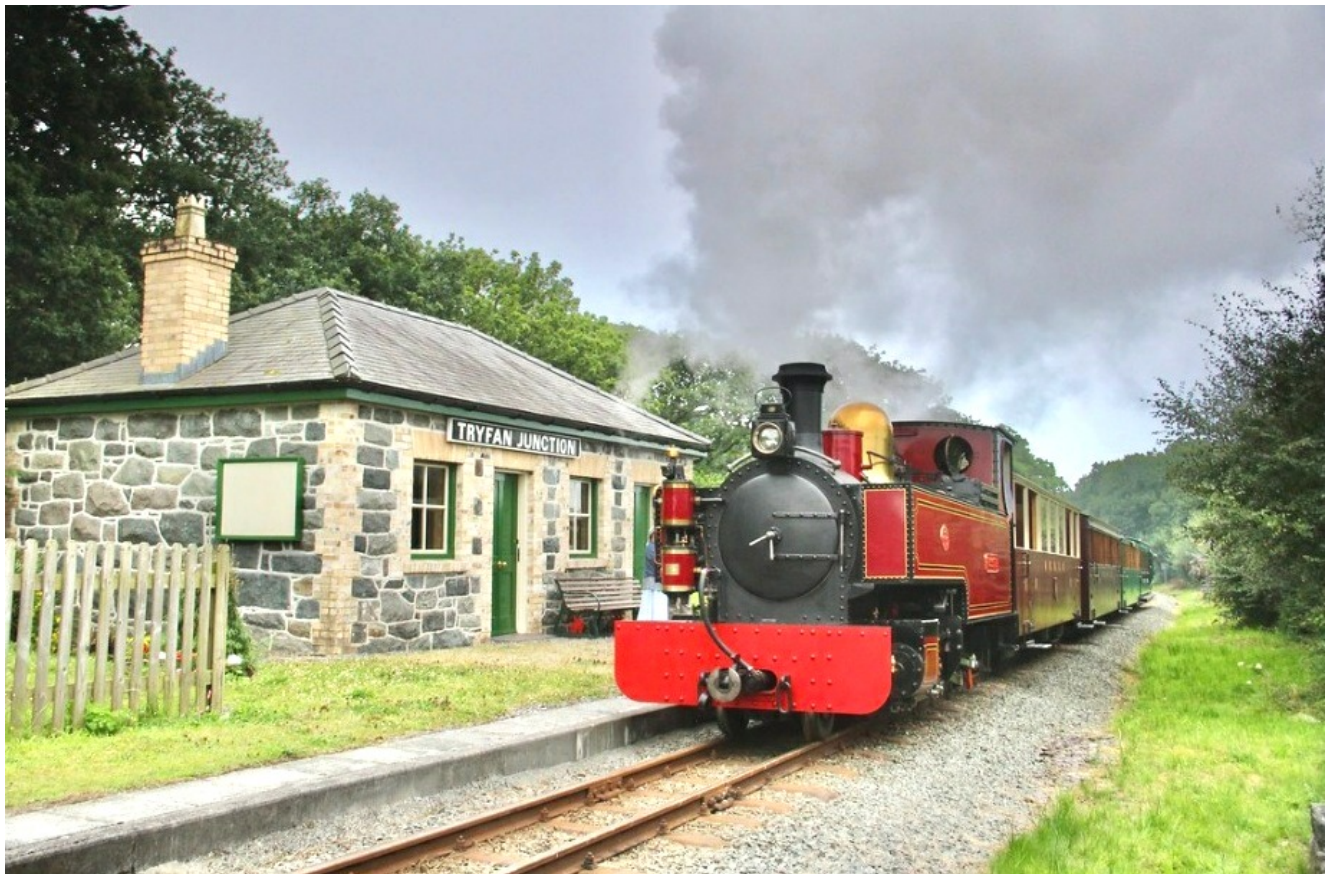
Russell with a four-coach train heading east through Tryfan Junction Station on the 1922 Centenary Weekend. As noted on page 1 of this Issue, the 4 carriages were: the Metropolitan Observation Car (The Gladstone) of 1891, the 2010 replica of NWNGR Ashbury 'Corridor' NWNGR No. 9, the fully restored Ashbury Corridor NWNGR No. 10 configured as the WHR Buffet Car in which form it served between 1927 and 1929 as WHR No. 24, and the 2021 Replica of Pickering Brake Composite NWNGR No. 8 - Photo by Jon Potter.
