# WELSH HIGHLAND

# HERITAGE

Issue No. 30

December 2005

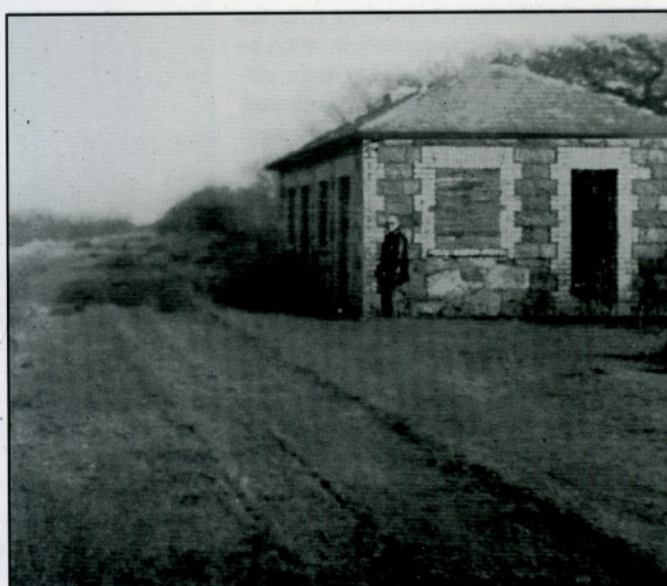
Tryfan Junction in 1942, with a lone passenger looking for the last train, which had run five years previous! Grass covered rails still in situ, as are the upright slates which defined the platform edge.

It is interesting to chart the history of this remote but idyllic station. It stands at the fork in the track where the Bryngwyn branch parted company with the main line. As planned the Bryngwyn branch was to have been the main line and the line to Rhyd Ddu the branch, but in the event these plans were reversed. However, the station was well able to accommodate either option. But even so, after this somewhat muddled birth it was downhill all the way. On opening in 1873 it was a fully staffed station; later it shared staff with Rhostryfan and Bryngwyn stations. Finally it was downgraded to a halt in 1934, fell into further decline and became derelict after closure. James Boyd accurately describes the station as being in "one of the remotest of places", where "occasionally some folk might have changed from a Dinas-bound train for a Bryngwyn-bound one" - a happy thought!

In its heyday the Junction was controlled by no less than seven signals operated from the wooden signal box opposite the station building. The stone base of this box still exists and

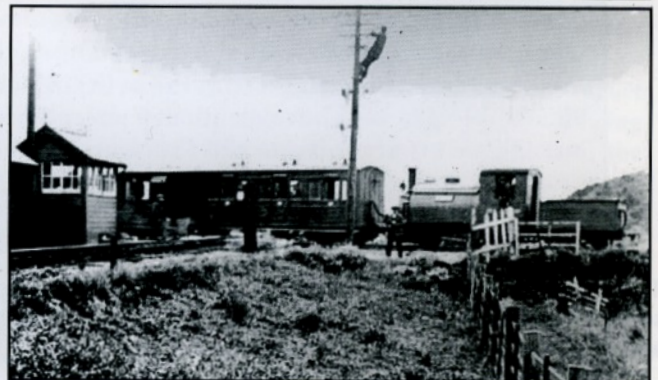
'Welsh Pony' and a Welsh Highland train cross the Cambrian heading to Harbour.

The two views accompanying John's article are particularly interesting. The track materials visible do not appear to be the same in the two photographs, indicating that the crossing had been renewed at some stage in its WHR career.

The photograph at the top of the article is none too clear, but some distinct differences between the materials seen in the two photos are apparent. The differ-

(1) In the top photo, the check rails on the crossing appear the same width as the running rails, suggesting that old running rail has been used; in the bottom photo, steel angle has been used in place of check rail.

(2) The top photo shows, on the standard gauge, that transitional rail joints are fishplated together; the bottom photo shows the rails butt jointed on timber baulks.

(3) Top photo - on the standard, and possibly narrow gauge, the transition chairs appear to be "normal" variety with keys, whereas in the bottom photograph, special chairs were employed. The latter were bolted through the webs of the rails, and fixed down to longitudinal baulks.

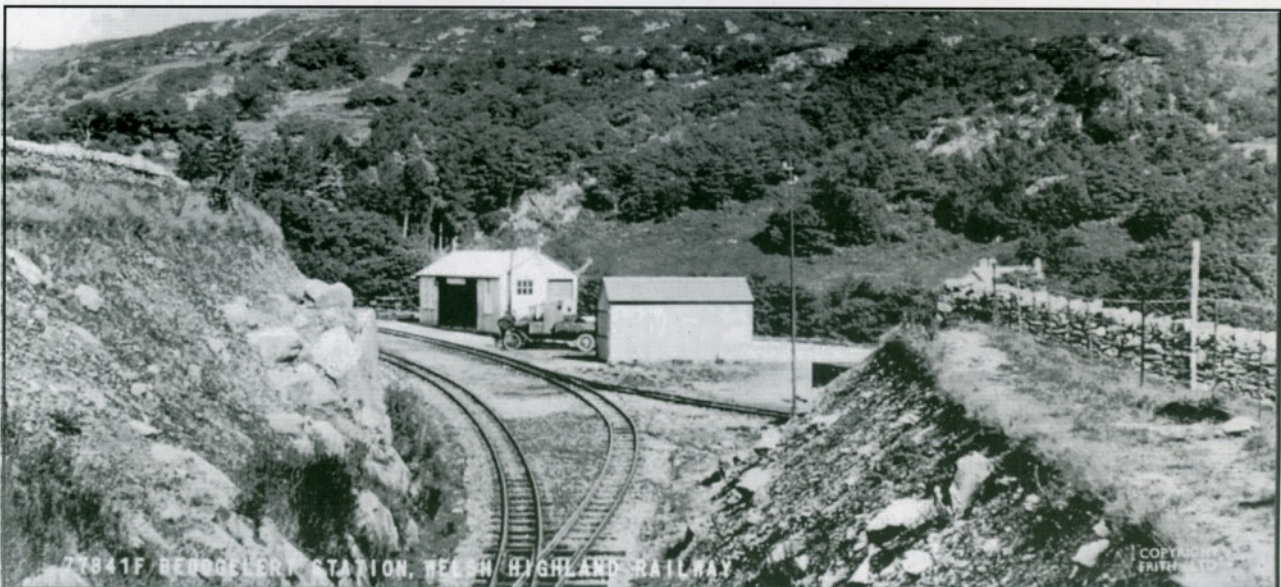
A splendid 1925 Frith photograph showing the coal siding at the southern end of the station lay out

A facing connection has been laid in the loop (platform) line at the south end of the station to serve a dead end coal siding 96 feet long on the east side of the line.

The points are worked by hand lever, locked by means of a padlock and key on the Beddgelert — Croesor Junction staff. A scotch is also provided, instead of trap points, similarly locked. The gradient of the line here is 1 in 42.8 falling towards Croesor Junction, the siding being also on a falling gradient away from the loop line.

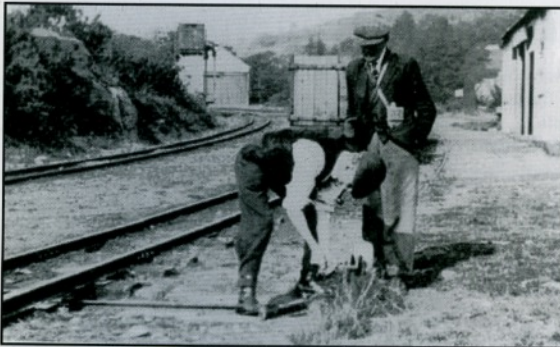
Padlocking the coal siding points  
Photo : R.J. Plummer 1928

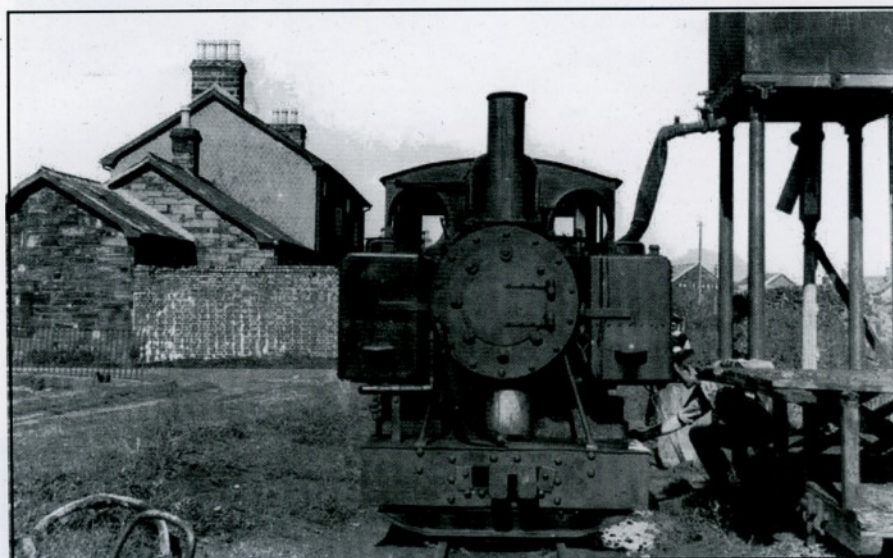
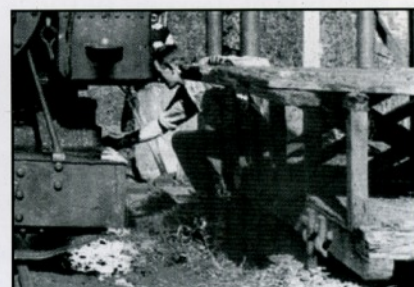
Fig 2 - '590', now turned with grounded coaler bottom right - see detailed enlargement below. Photo : 1934 - G.H.W. Clifford

Figs 2 & 3 are clearly post-1934, as the Baldwin has been turned. The distinctive X bracing of the coaling stage reveals its origins in the mobile facility, but now grounded. In the two enlargements (Detail 2 & 3) it can be seen that the platform has been extended upwards. The redundant axleboxes can also be seen; they are typical of the type fitted to FR wooden framed goods stock, including slate wagons and the existing bolster set. The suggestion of a curved end beam and the large solebars, together with the presence of a floor below the X bracing lead me to conclude that the mobile coaling stage was built upon the

cut down chassis of either a wooden slate waggon or a bolster. Unfortunately I have not yet found any mention of this conversion amongst the FR wagon records that I have been able to consult so far.
