WELSH HIGHLAND HERITAGE

Issue No. 59

March 2013

Progress with Tryfan Junction & Beddgelert Projects

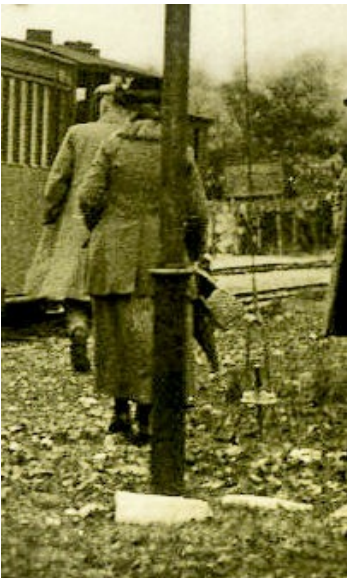
Above right - an enlargement of the top of the pole at Snowdon station showing the insulators mounted on brackets, but no wires, and the possible lightning conductor. There appear to be other clamps mounted on the post possibly for electrification anchor cables, or mounting brackets for the cable support arms. Left - the foot of the pole showing the parallel section and the ‘ring’ or ‘boss’, plus tensioner for the ‘guy’ cable.

above Cwm Cloch and at Pont Cae'r Gors. The posts were set in concrete, and tapered upwards from the base which was circular in cross section. There was an ornamental ring or boss of greater diameter at the transition, a couple of feet or so above ground level. A very clear photograph exists, showing one of these poles at Snowdon (later South Snowdon) station; I estimated from scaling the figures standing just behind the pole that its height must have been around 30 feet!

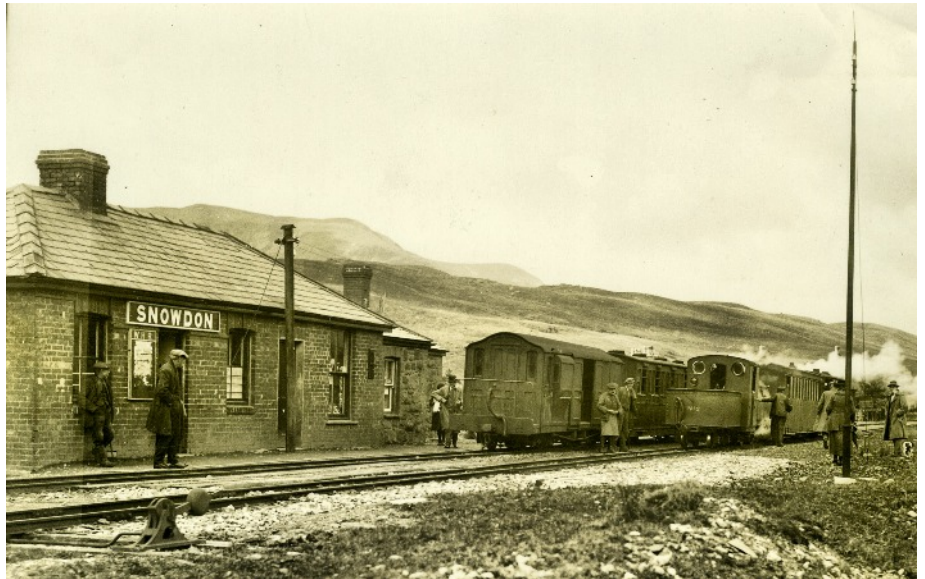
The photograph taken in early WHR days at ‘Snowdon’ station, before it was renamed ‘South Snowdon’. One of the tall metal posts is clearly visible on the right hand side, with a supporting guy cable. There are two insulators mounted above one another towards the top, and what appears to be a lightning conductor atop the post. A conventional timber telegraph pole is in place alongside the station building; this was erected some years previously and appears in older photographs. The shape of the insulators suggests that this could have been an electricity supply pole, but lurking behind the visible insulators on the cross piece are two more, of the typical ‘telephone’ shape. Indeed twin phone wire can just be made out leading away from the pole..

Close examination of the photograph taken at Snowdon shows two insulators of the telephone type (white porcelain 'pots') as opposed to the brown, squat electrical type shown in the accompanying pictures. The insulators observable in this and other photographs appear to be mounted at the very top of the poles, with no visible means of ascending the posts for line maintenance. This seems extraordinary, as the lack of pole steps would have made repair work very difficult. There were no 'cherry pickers' in those days!

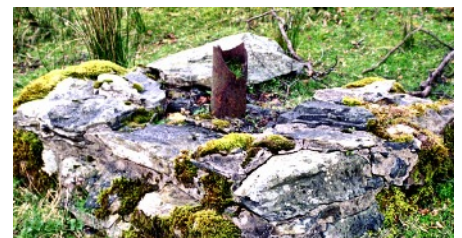
Stump of a metal pole near Hafod y Llyn set in a stone & concrete base

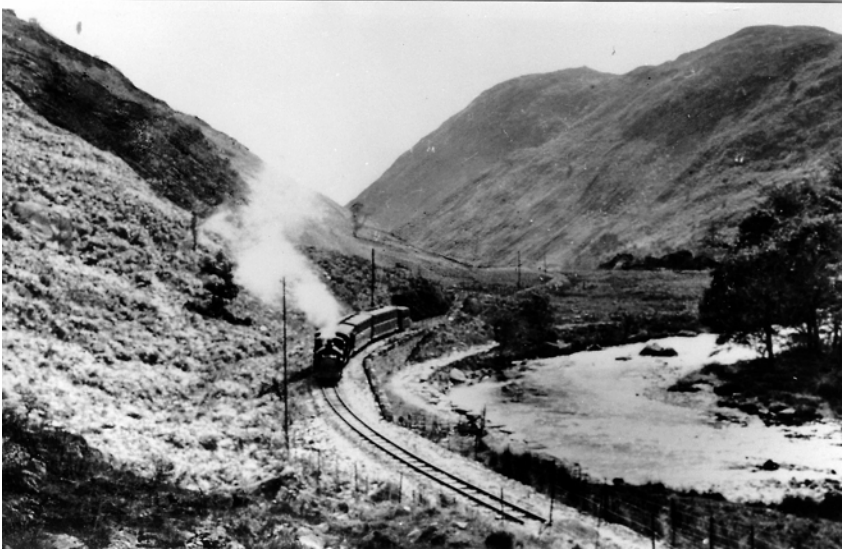
WHR train hauled by an FR England engine in the Aberglaslyn Pass, close to Bryn y Felin. Note the metal poles, mounted in staggered fashion and not paired across the railway

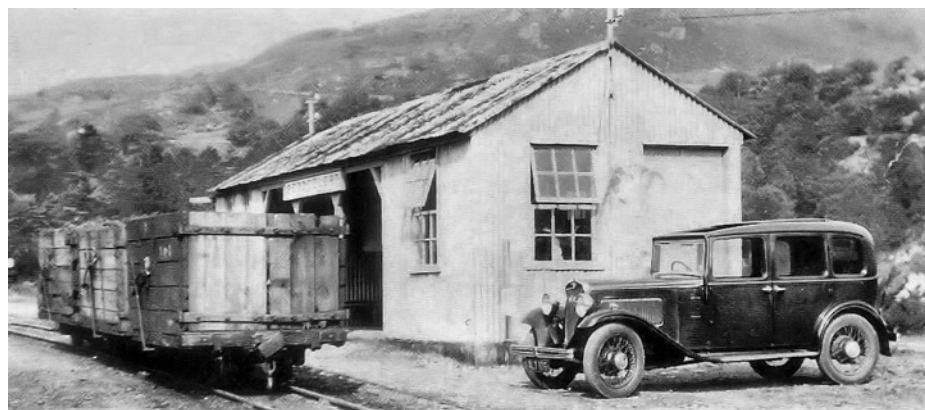
FR wagons and an Austin car at Beddgelert in 1928. Just visible is a telephone wire which is going from the insulator on the roof of the building towards the town rather than to the metal pole close to the cutting. R.R.J. Plummer

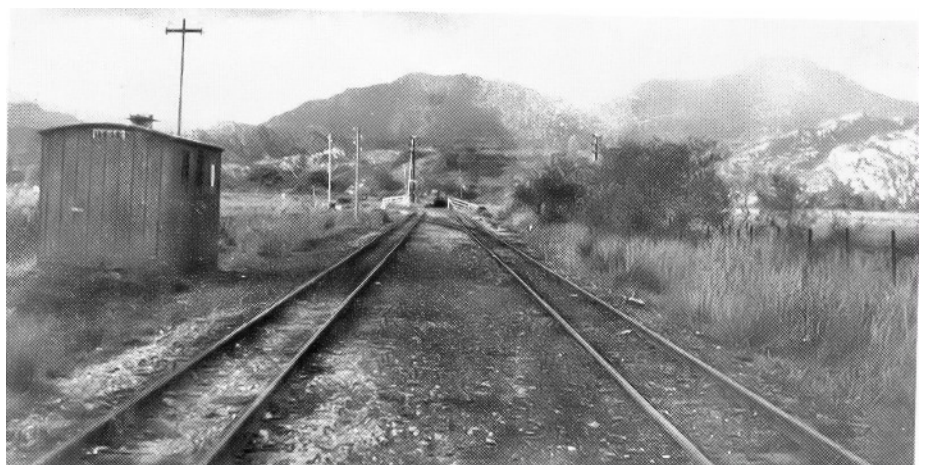
Croesor Junction in W.H.R. days showing the primitive station 'building' (an old FR Quarryman's Coach) and what appear to be conventional wooden telegraph poles with wires attached thereto. The pole with crossbar above the coach body has an unknown purpose but is likely to have been for telephone wires. Power lines go from left to right in the middle distance: were these a part of North Wales Power's transmission line system?

As previously mentioned, metal poles seem to have been scarce – or even non-existent – south of the Afon Nanmor. A photograph of Croesor Junction appears to show conventional timber poles with telephone style insulators, mounted in staggered fashion on opposite sides. It would seem, therefore, that the W.H.R. wires were carried on 'normal' poles for at least some of the distance south of the Afon Nanmor.

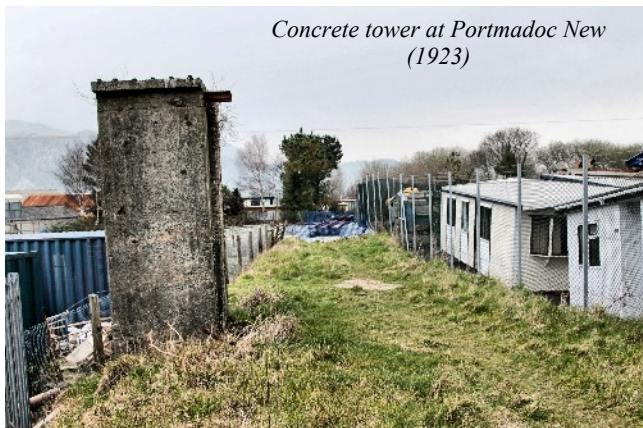
Concrete tower at Portmadoc New (1923)

With the advent of concrete subsequent WHR water towers had a less decorous appearance. Only two ‘permanent’ structures were built – at Portmadoc New (1923) and Beddgelert. Although there are many photographs of locomotives taking water at Beddgelert none have yet come to light showing the ‘Port’ tank in use. Perhaps this is because locomotives took on water at Harbour. Study of the various photographs of Beddgelert water tower reveal two water feed pipes – one facing the main line and the other at the back. One can only assume that when feed was put on the mains the original ram fed facility was left in situ. When the replica tank is up and functional locomotives will be able to water on both running line and extended siding.

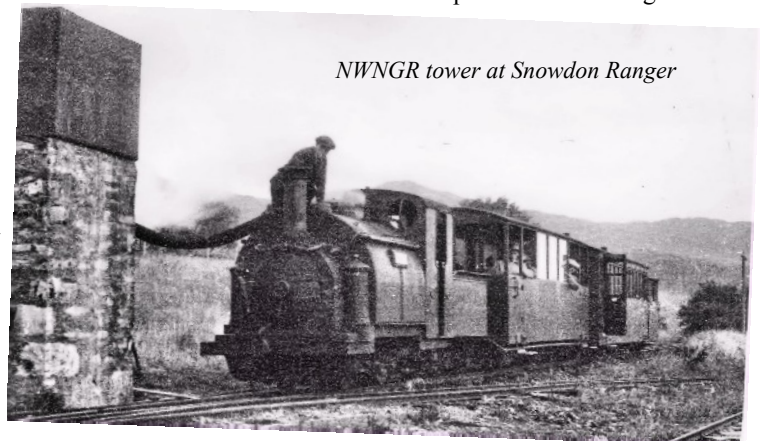
NWNGR tower at Snowdon Ranger

Moving south the next water available was at Snowdon Ranger/Quellyn Lake presumably installed when this location was, for three years, the railway’s temporary terminus (1878 – 1881). Having established a ram fed facility here there would have been no need for a water tower at Snowdon station (Rhyd Ddu).

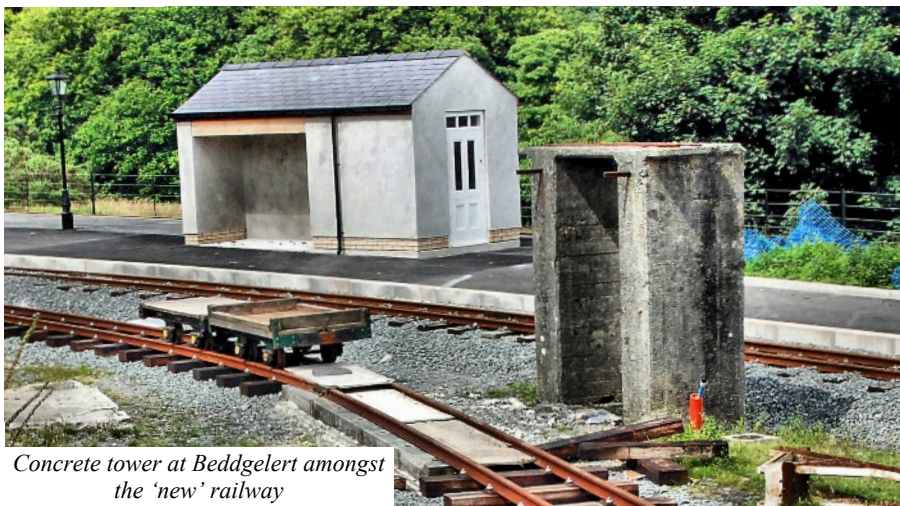
Concrete tower at Beddgelert amongst the ‘new’ railway

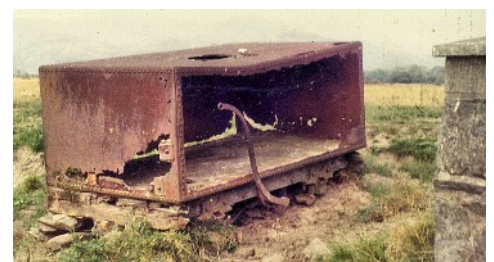
Remains of the brine wagon ‘tank’ at Pont Croesor
