WELSH HIGHLAND HERITAGE

Issue No. 61

Chronicles of Beddgelert Siding (II)

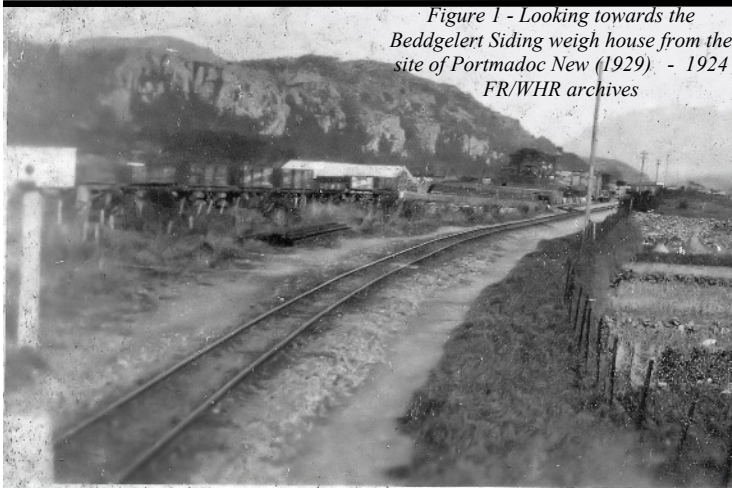
Figure 1 - Looking towards the Beddgelert Siding weigh house from the site of Portmadoc New (1929) - 1924
FR/WHR archives

Although of indifferent quality, Figure 1 offers much of interest. The photographer was standing at the site of what would later become Portmadoc New (1929). The waiting shelter eventually installed here would stand to the left of the track, outside the gentle right-hand curve seen in the image.

The second telegraph pole visible in Figure 1 is distinct in that it carries two cross arms and is readily identifiable in Figure 3, taken by Geoffrey Hoyland in 1936.

Both Figure 1 and 3 will confirm that this particular pole was installed beyond the first turnout encountered on the approach to the interchange sidings. Figure 1 arguably gives the better view of this first turnout, showing the operating lever to the left of the track and

The first telegraph pole seen on the right of the image can be seen in photographs that show the waiting shelter, for example the 1936 image credited to H.B. Tours.

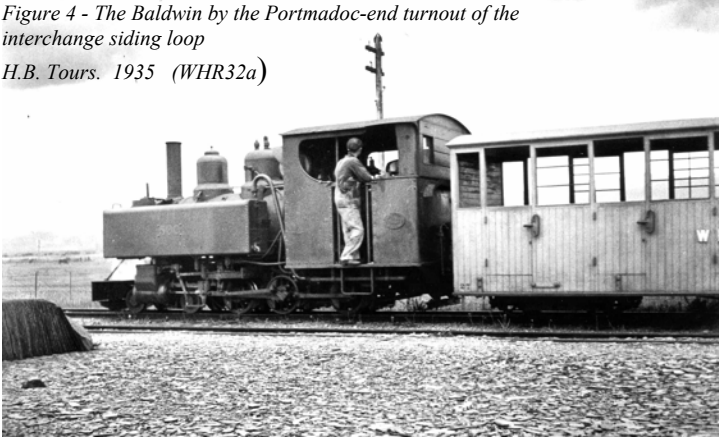
Figure 4 - The Baldwin by the Portmadoc-end turnout of the interchange siding loop

The distinct nature of this second pole allows us to place Figure 4 relative to the first loop turnout. As will be shown later in these notes, this end of the narrow gauge loop was not available for run-around manoeuvres when trains reversed north of the Cambrian Crossing.

examination of the poles on the left shows our friend with the two cross-bars to be the third in line. This pole it has been noted stood close to the turnout at the far end of the loop. It is likely that there was another pole just off the left hand side of the image, suggesting that the overall

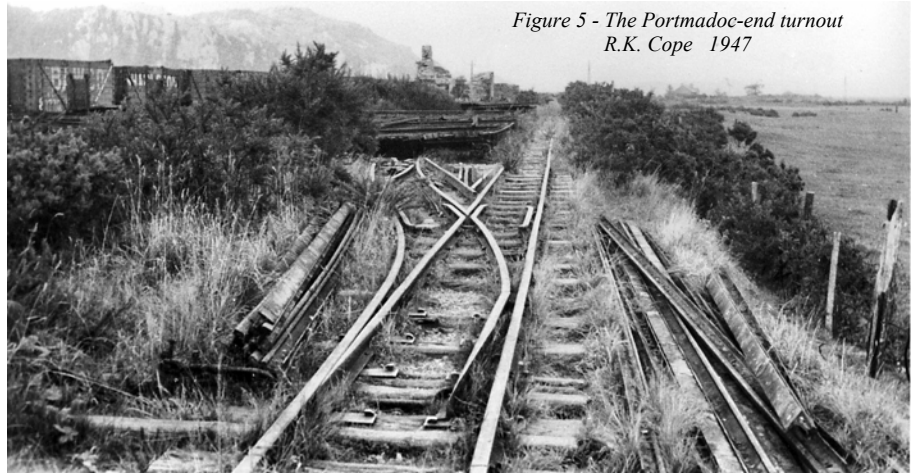
Figure 5 - The Portmadoc-end turnout
R.K. Cope 1947

Figure 5 shows the Portmadoc-end turnout in close up, albeit several years after the railway closed. Note the extended sleepers running to the left at the nose of the turnout,

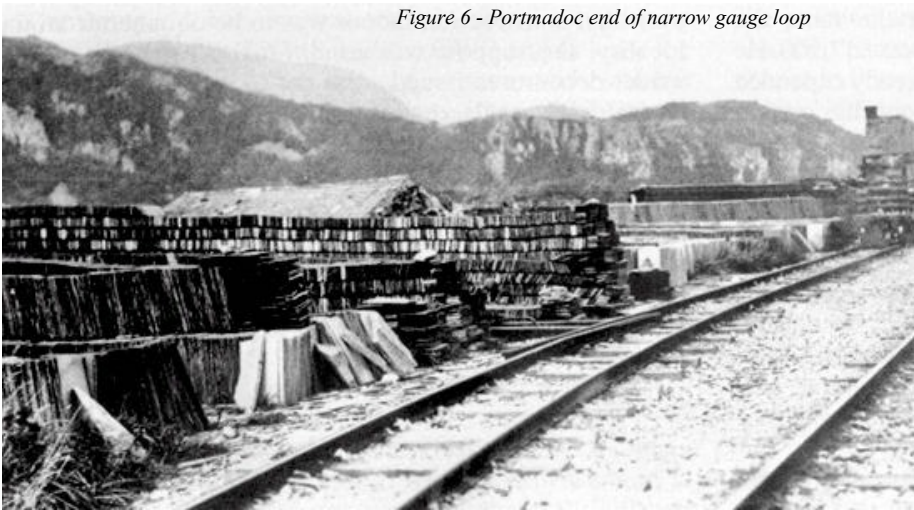
Figure 6 - Portmadoc end of narrow gauge loop

Figure 6, taken before the layout disappeared under recovered materials, affords us a view

further into the narrow gauge loop and clearly shows the location of the trap point - together with its operating lever set off to the left - protecting the Portmadoc end of the loop. It would appear that when this photograph was taken the trap was operated independently of the turnout lever.

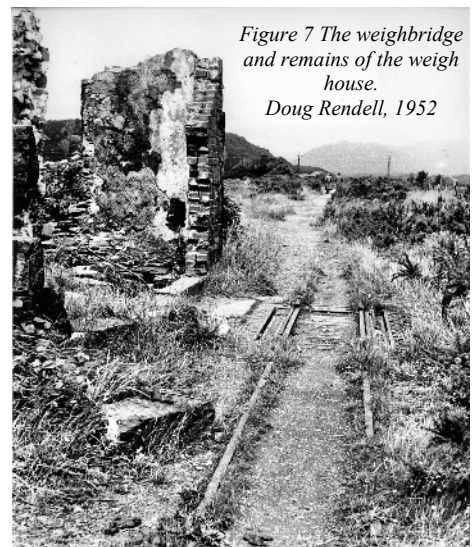
Figure 7 The weighbridge and remains of the weigh house.
Doug Rendell, 1952

If proof were needed, Figure 7 confirms that the weighbridge lay directly outside the weigh house on the narrow gauge loop line (note, for the record, that in WHH Issue 19 - March 2003 - this image location was incorrectly identified as Glanrafon). This photograph offers little by way direct

However, in conjunction with Figure 7, the content of Figure 8 is informative.

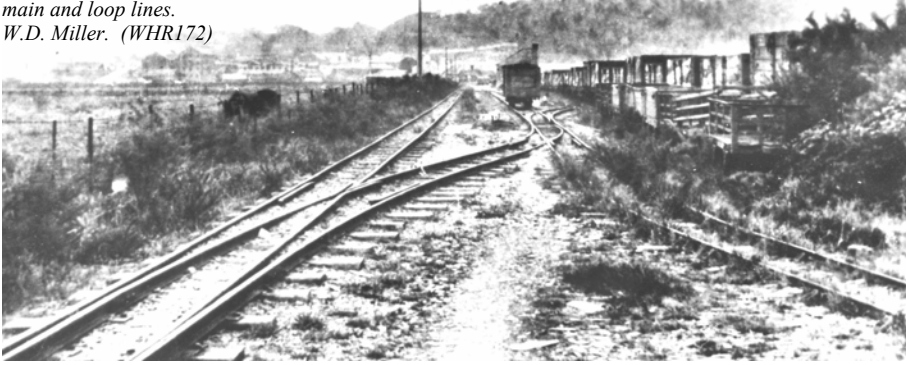
Figure 8 - Looking towards Portmadoc along the narrow gauge main and loop lines.
W.D. Miller. (WHR172)

In the middle distance, Figure 8 shows there to have been a cross-over between the main and loop lines, arranged facing Portmadoc for trains on the main line, and positioned somewhat nearer to the camera than the weigh house and hence the weighbridge. Although indistinct in this reproduction,

Further items of interest in Figure 8 include the turnout facing the photographer just in front of the wagon parked on the loop. The narrow gauge wagons apparently abandoned to the right of the image suggest a siding running parallel to the standard gauge - note the long line of standard gauge wagons - access to which was achieved by what was in effect a crossover between the loop line and this double-ended siding.

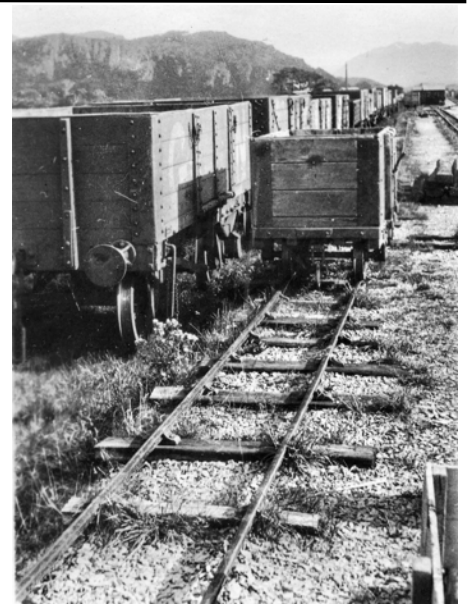
Figure 9 - The narrow-gauge siding adjacent to the standard-gauge line, looking towards Beddgelert.
K.F. Antia 1924/5 (WHHG51)

This siding is clearly shown, looking in the opposite direction, in Antia's photograph

which we believe was taken either in 1924 or 1925 (Figure 9).

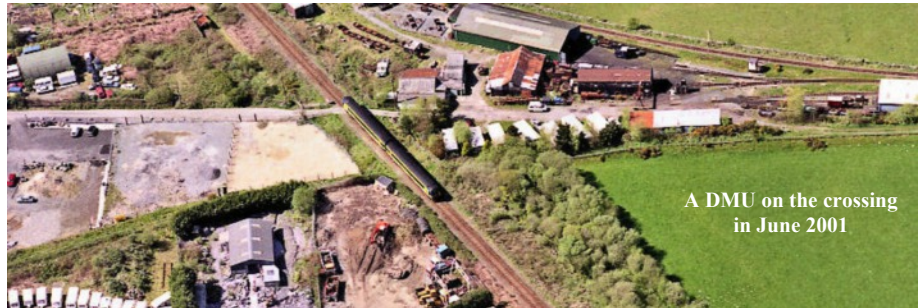
A DMU on the crossing
in June 2001

The Engineering Dept. will have absolute occupation of the single line between Minffordd and Portmadoc at 119m. 51 1/2 ch. on Sunday next the 28th instant, from 7.0am to 5.0pm for the purpose of relaying crossing at Croesor Crossing. Token to be withdrawn after passage of the last train on Saturday, October 27th and placed in the box provided in Portmadoc West Cabin. The token to be replaced in the box by the Permanent Way Inspector on completion of the work on Sunday, October 28th.

Alas, the gang's handiwork had only a limited life, for (as recorded in *WHH 58*) the crossing was removed and replaced with plain line on Monday 27 December 1937.

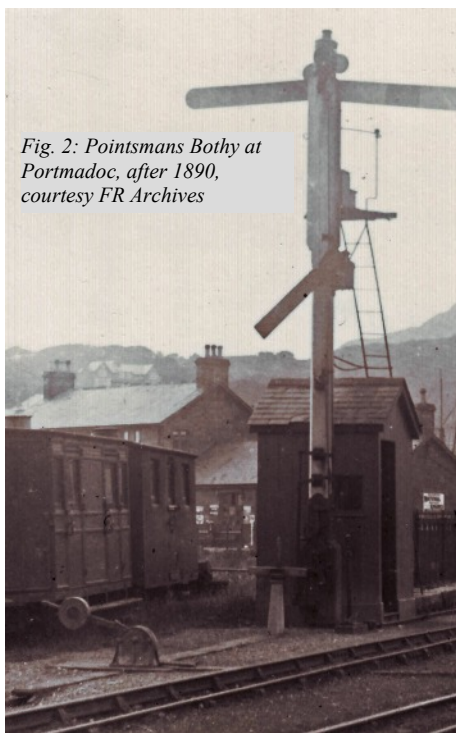
Fig. 2: Pointsmen's Bothy at Portmadoc, after 1890, courtesy FR Archives

Of note is that the bothy had gone by this stage. It is recorded as being built ostensibly to house the 'locking': in practice all the locking was external to the building and the building at the most would have contained the block telegraph instruments, a booking desk and block register with a telephone. Closure and relocation of the signalling facilities into the main building would therefore be straightforward when the Light Railway Order (LRO) simplifications came into force. It is a matter of record that the Miniature Electric Train Staff (METS) was fitted to the Minffordd - Boston Lodge section on 30/5/1921 and the Boston Lodge instrument moved to Portmadoc in October 1923 when Boston Lodge closed; close examination of Fig. 3 does not easily reveal the usual FR practice of a METS drawer lock releasing the groundframe. What this picture does clearly illustrate is the unique semaphore signal at Portmadoc; it was the only double arm signal known to be fitted with external coloured spectacles. I do not know if this was as a result of confusion with ship lights: parts of the nearby

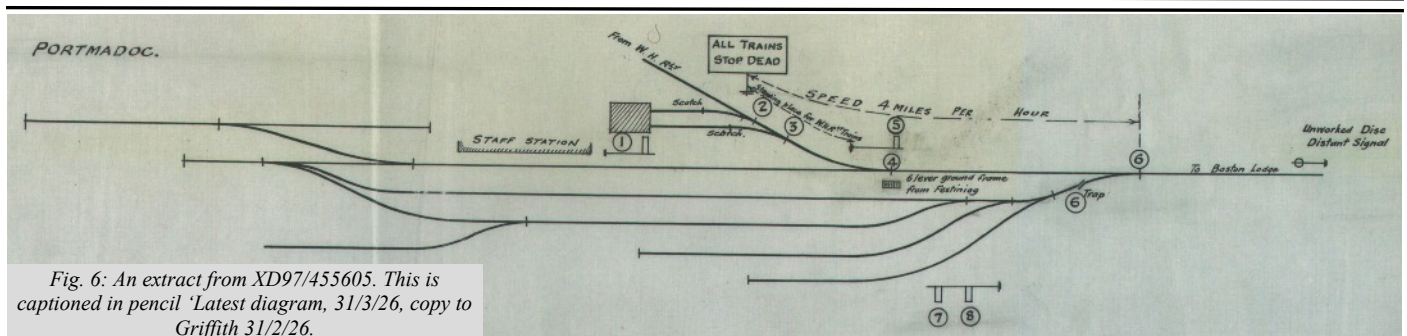
Fig. 6: An extract from XD97/455605. This is captioned in pencil 'Latest diagram, 31/3/26, copy to Griffith 31/2/26.

the only completely dated drawing of the arrangements at Portmadoc: Fig 6.

Aside from the February/March confusion, I suggest that it is clear that the combined companies were attempting to sort out and modernise the signalling at Portmadoc in preparation for the 1926 season – Griffith being G. Lewis Griffith the F&WHR track inspector. In and of itself this diagram raises some very pertinent points – most notably the comment of '6 lever ground frame from Festiniog'. Students of Festiniog signalling history and readers of Boyd would be hard pressed to find this groundframe at

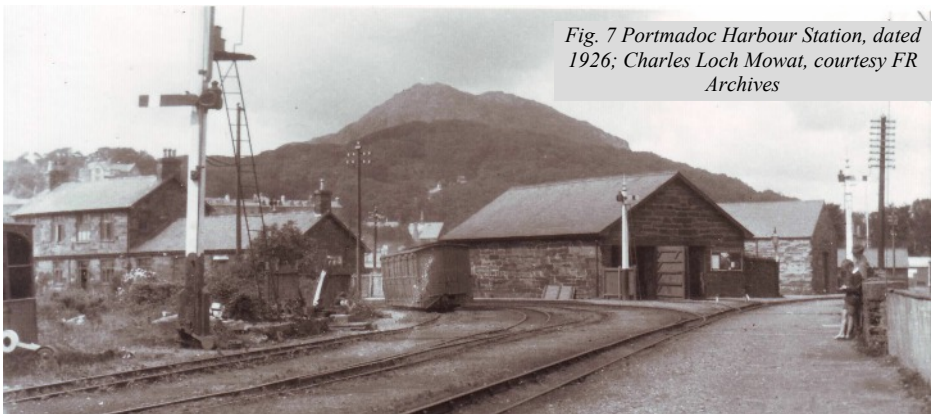
Fig. 7 Portmadoc Harbour Station, dated 1926; Charles Loch Mowat, courtesy FR Archives

lines are also prominent. It is a shame that the top of the signalpost for approaching FR trains is missing from the picture, but I am reasonably sure that there is only one arm absent and that arm would apply to Festiniog trains going into Harbour Station. The ground frame itself is interesting, it appears to be directly opposite the Britannia Bridge points; comprising a six lever frame with only five in use – lever 6 is painted white, denoting a spare. Note too that the signal has been converted to a much more ‘conventional’ signal worked by wires from

We know from the evidence of Figure 7 that lever 6 was originally spare, and that the furthest remaining points at the Boston Lodge end of the layout were originally released by the METS as recorded in the Archives blueprints. From that there would be 5 levers in use in the ground frame: 2 signals for each direction and the Britannia Bridge points. As there is no obvious separate FPL lever [4], the sole set of points must have been locked economically with a combined point and lock movement. As I mentioned earlier I have never seen any evidence of locking actually at the blades of the Britannia Bridge points, so the FPL must have been remote from the blades over by the fenceline as seen in the c. 1890 photograph – or directly in front of the Tyers lever frame. Figure 8 suggests that the economical mechanism was in the lead-off trench with a drive rod to the blades and a separate locking rod from the blades. It is also recorded that the ‘Trident’ was moved

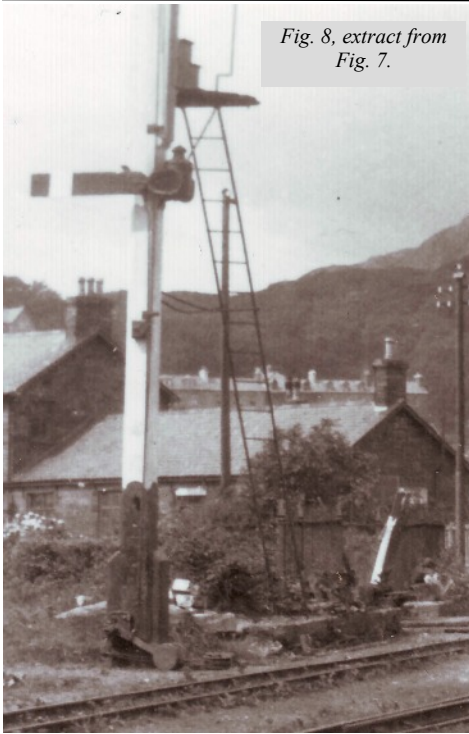
Fig. 8, extract from Fig. 7.

Crucially for our discussions it is clear that there is only one point rod going in the Boston Lodge direction and with a little bit of digital enhancement of the picture there are two rods just about discernable heading in the direction of the Britannia Bridge points. Also from this angle lever 6 looks to be in use. Importantly too, lever 2 is reversed, and in the distance we can see the ‘Trident’. Digital enhancement and inversion of the image clearly shows that the main arm on the centre doll of the ‘Trident’ is ‘Off’ meaning that most likely there is a train due into the Harbour Platform. This is most probably the ‘Rosetta Stone’ for deciphering the frame numbering at Portmadoc. There are a lot of factors to consider in piecing this information together. We must begin with the thorny

the lever frame. An extract from this picture reveals even more detail. (Fig 8)

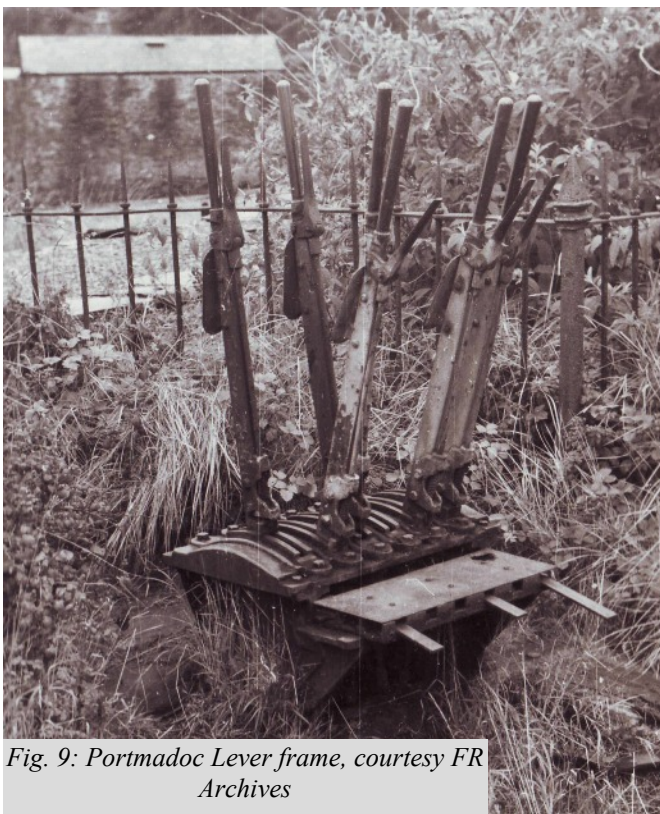
Fig. 9: Portmadoc Lever frame, courtesy FR Archives

This photograph has enough clarity to enable us to deduce that the lever frame was made by Tyer’s, unfortunately due to the undergrowth it is impossible to decide whether or not this frame is to ‘Design B5’ or not, but this is certainly the frame that was originally intended for Glanypwll. Of note in Fig. 9 is the apportionment of levers – there is some vestigial interlocking left, with the tappets for levers 1, 3 and 6 remaining. Levers 1, 2, 4 and 5 are painted in the same colour. I suggest that these are the signal levers. Exactly which signals is still up for

Pending further photographic evidence, it is unlikely that we will ever be certain of the frame numbering beyond Levers 3 and 6 being the WH points and the New Quay points – Fig. 10 is not of the clearest. However, comparing Fig. 6 and Fig. 10, it is tenable that the 'Down' signals were levers 1 and 2 and the 'Up' signals were levers 4 and 5. Fig. 10 gives a very strong suggestion that the central arm of the 'Trident' is 'Off' with lever 2 pulled. In pre-'Trident' days this must have worked the higher one of the two remaining arms on the old station semaphore – the lower arm would have continued to apply to the Wharf Line (now the WHR) and must therefore have been controlled by lever 1. When the 'Trident' was installed, both wire runs would have been extended out onto the Cob, but removing the staff lock from the 'New Quay' points complicated matters: there were now more signals than levers. The only plausible solution I can think of is that there must have been a 'floating wheel' selector working with the two boxes visible in Fig. 5. These boxes between the wave wall and the running rails would have detected the position of No 6 point blades, so depending on the lie of the points either the centre arm or the leftmost (ringed) arm would clear. Why isn't there a third box (or evidence thereof) for the wire run from No 1 lever to the signal? Well, bear in mind that the selection/detection arrangements could be greatly simplified under the LRO, and there would be a bit of 'dead locking' (interlocking) between levers 3 and 6. Neither lever could be reverse at the same time, both levers would be free when both were normal [6] but as soon as one lever

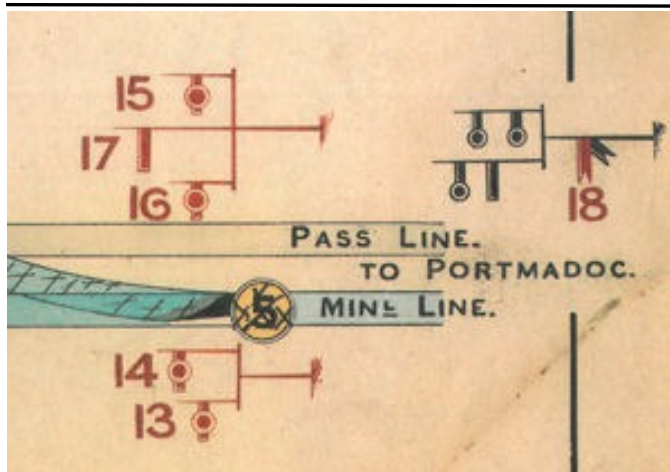
Fig. 11: extract from XD97/459027, courtesy FR/WHR Archives

down from Duffws in 1929 giving a likely window of opportunity for the alterations to the control of the points. The 'Trident' was formed of signals 15 – 17 from Duffws, as illustrated in the original McKenzie and Holland diagram, Figure 11:

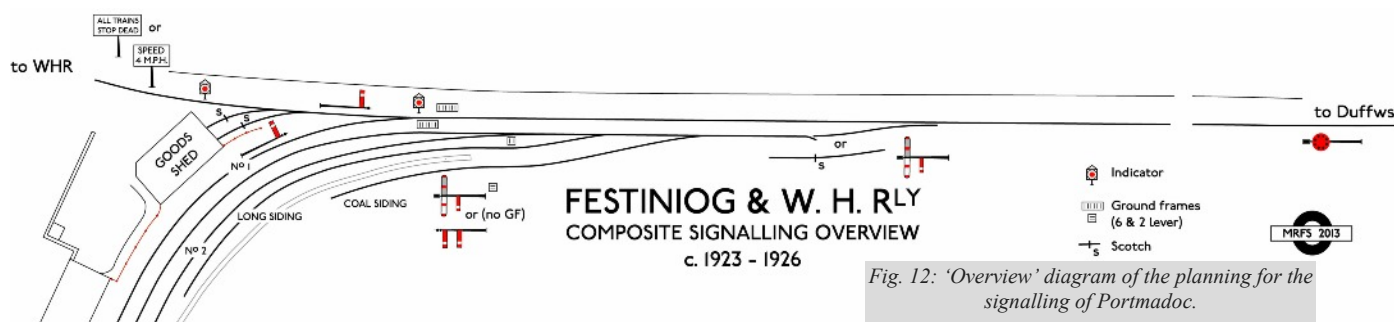
Fig. 12: 'Overview' diagram of the planning for the signalling of Portmadoc.

lever frame that the operator would have stood looking towards the Britannia Foundry. XD97/455110 is by no means an 'official' signalling diagram, these are just planning doodles and may well have had no basis in reality. If you look at Fig. 12, which is a synopsis of all the different iterations in the Archives, you can easily see that many different possibilities were discussed at Tonbridge and/or Portmadoc.

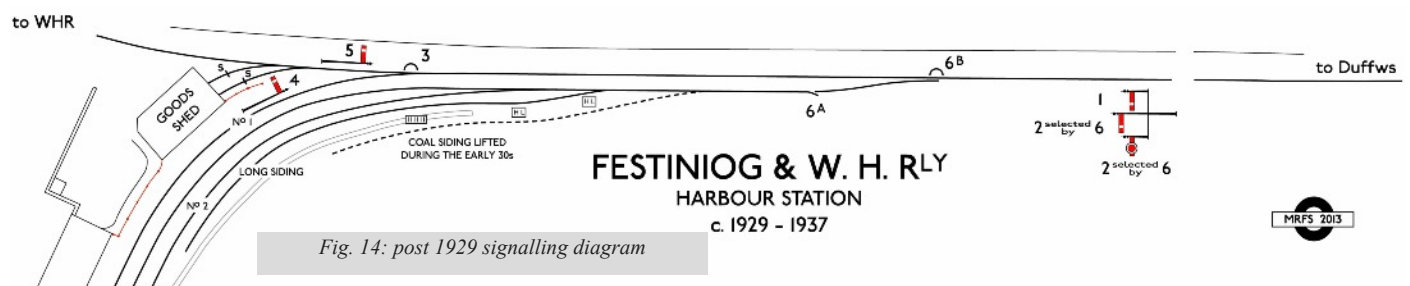
Fig. 14: post 1929 signalling diagram

think that this is the most likely result. The length of running line between the Stop Board and the WH Stop signal is denoted in the blueprints as the 'Stopping place for WHR trains' with a dashed line between the stop board and the stop signal. I do not know what precipitated the use of the 'Trident', but as the signal must have been at least 60 years old then the old post would surely have been ripe for replacement in 1929, resulting in figure 14. Photographic evidence has recently come to light of the 'Trident' and the original disc in situ. I do not know when the disc signal was recovered, but it would appear to be after 1929.

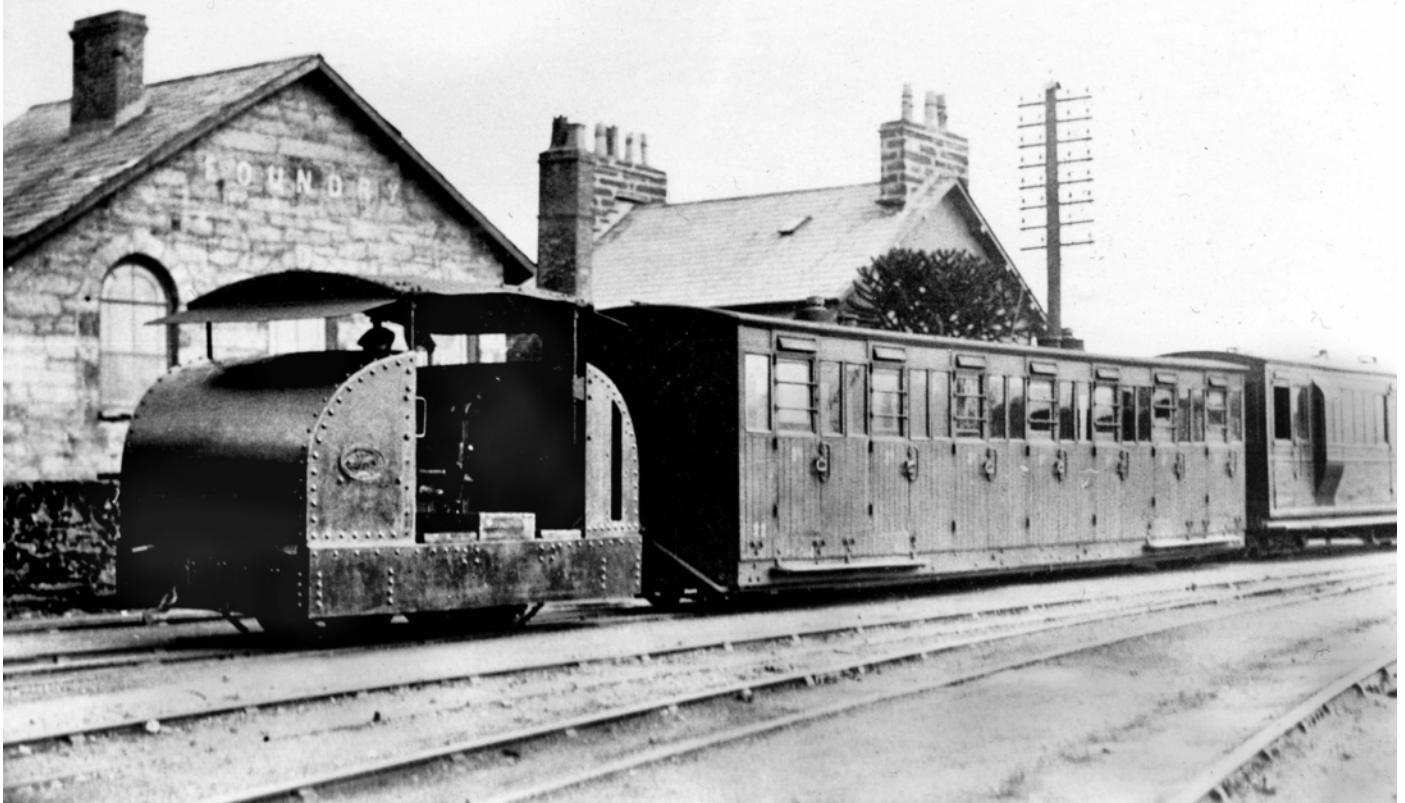
The above photograph – from Peter Johnson’s collection – shows the Simplex and its test train with which Col Stephens flirted as a possible solution to working the Bryngwyn branch and a winter service on the main line, reference to which was made in *WHH* No 60. Attached to the petrol tractor is FR carriage No. 22 and WHR Pickering brake composite. The photograph appeared in the *Railway Gazette* for November 1923 and was taken by a representative of that magazine who had been invited to attend the trials

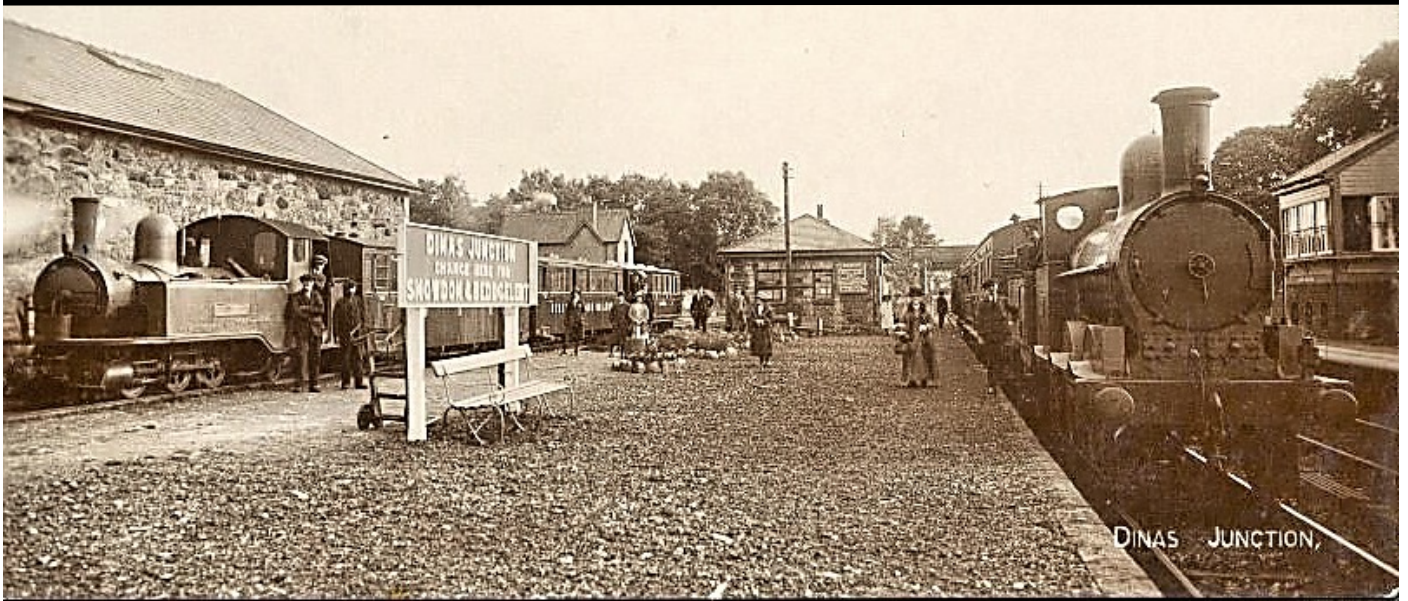
Peter Liddell comments on this clearly posed 1925 print taken at Dinas Junction. Mention has been made that the standard gauge loco in this view is running 'wrong line'. The standard gauge lines within the Dinas Junction layout were signalled for bi-directional running. In other words, either line could have been used in either direction. This can be confirmed by examination of photographs that show the pairs of signal at either end of the platform. Consequently, there was no question of "wrong line" running — the station authorities could, presumably, select the

preferred line for each movement. If trains were not scheduled to cross, it would presumably have made sense for north-bound trains to stop at the east platform instead of the "usual" western road, easing interchange with the Welsh Highland and passenger access to the road and the village.
