WELSH HIGHLAND HERITAGE

Issue No. 70

NWNGR (?) / WHR COVERED VANS

Capstans and Stop Boards.

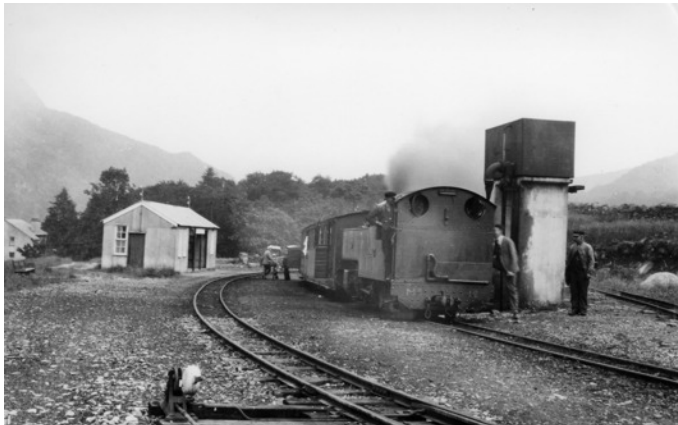
A northbound train stands on the 'main' line at Beddgelert in 1928. The roof of a covered van can just be seen beyond the open door of the Buffet Car - WHR24 (LPC1661)

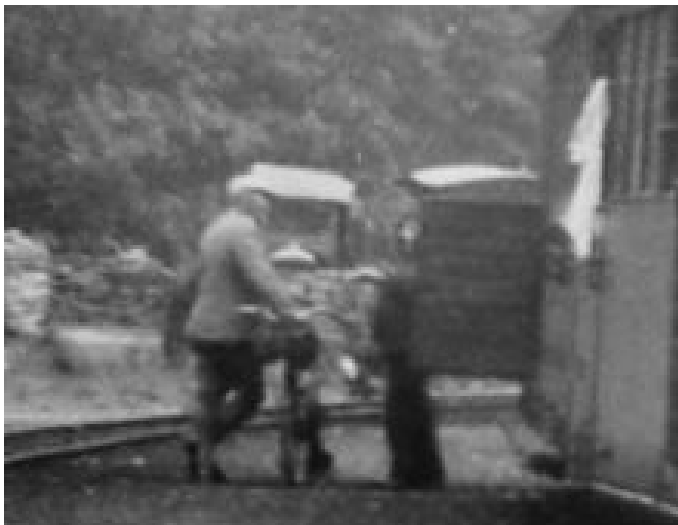
An enlargement from LPC1661 to show the covered van roof. Note probable goods transfer from the east side of the vehicle.

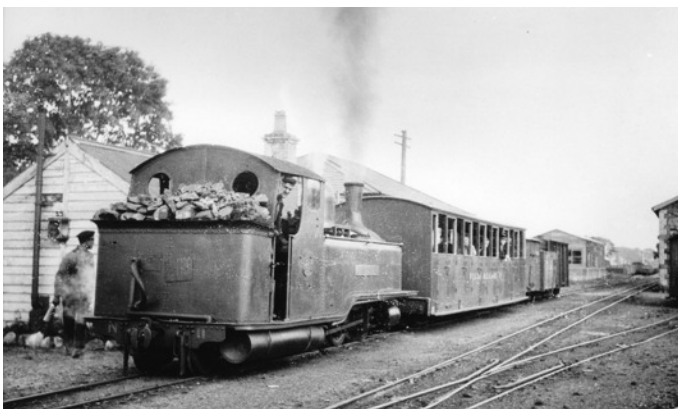
A mixed train photographed behind Moel Tryfan at Dinas Junction in the early 1930s. Note covered van no. 2 between the un-glazed ‘Summer’ carriage and the open coal wagon. This is the only image I have identified so far that shows the van from the east side - F.E. Box

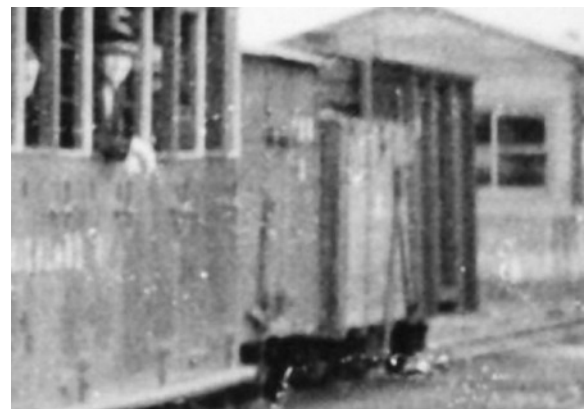
An enlargement from the ‘mixed train’ photograph showing the east side of van no. 2. The photograph shows not just the brake lever but also clearly shows 4 door hinges indicating that, contrary to previous accounts, this van at least had doors fitted to both sides.

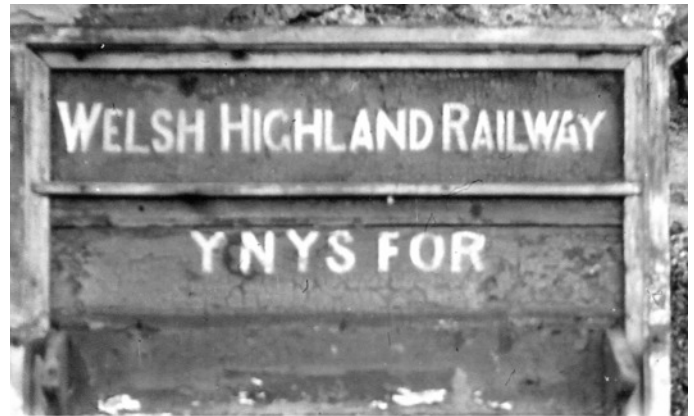
Figure 3. Timetable notice board rescued from inside the shelter.

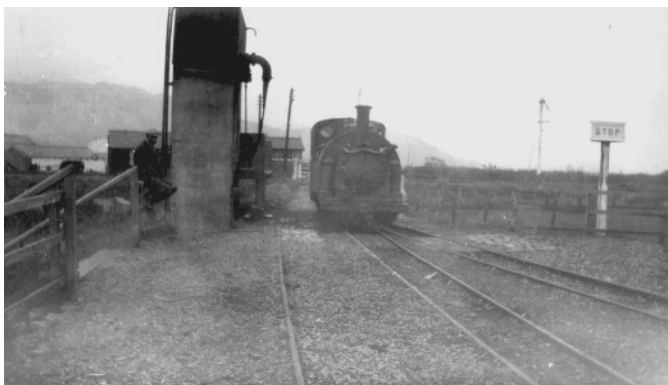
Figure 4 - Prince at Portmadoc New, mid to late 1920s. Courtesy
FR Archives, via Chris Jones.

Although somewhat later than the photograph of ME, Figure 4 shows there to have been some changes, not the least of which is that the stop board has changed; although remaining in the same position relative to the Cambrian, it

has moved some distance eastwards. I wonder if it is the same board from the other side of the crossing as shewn in Figure 3, where Portmadoc-bound trains just had a blunt ‘STOP’? I have previously speculated on the e-groups whether the apparent ‘waisting’ of the post was due to it being a reused FR Disc Signal capstan – sadly not. The apparent ‘waisting’ is an illusion from people with mucky overalls leaning against the post. Yet there are reused Disc capstans in the picture of Prince. Look carefully at the elevated stage, beyond the water tower.

The support posts underneath for the three sided enclosure screamed ‘Disc signal capstans’ as soon as I saw them: the 180° arcs were detachable, presumably to allow some

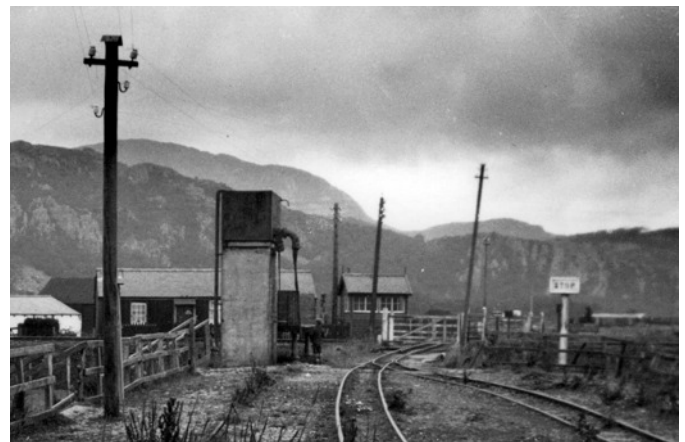
Figure 5 - Extract from Arch3938, Ken Hartley, 1931 (See Editor's
comments on photo references at the end of this article)

This photograph exemplifies the general air of desuetude that has settled on the southerly Portmadoc New. There is a clear view of the later stop board and the three-sided stage beyond the water column. Visible too is the southern trap point for Croesor Crossing, and the fence beyond the steps has now gone. Interestingly for a photograph of this era, the wires are visible on the telegraph pole sited on the loop platform. There are four wires – I suggest that the top two are the WHR telephone (and possibly the line to Croesor, but that needs further examination) and the lower two are most likely to be the private line from Greaves' Quarry in Blaenau that would have been heading off to Wern via the Cambrian Railway – this was not the single ‘quarry wire’ (Oakeley), so beloved of Festiniog linemen as it was on

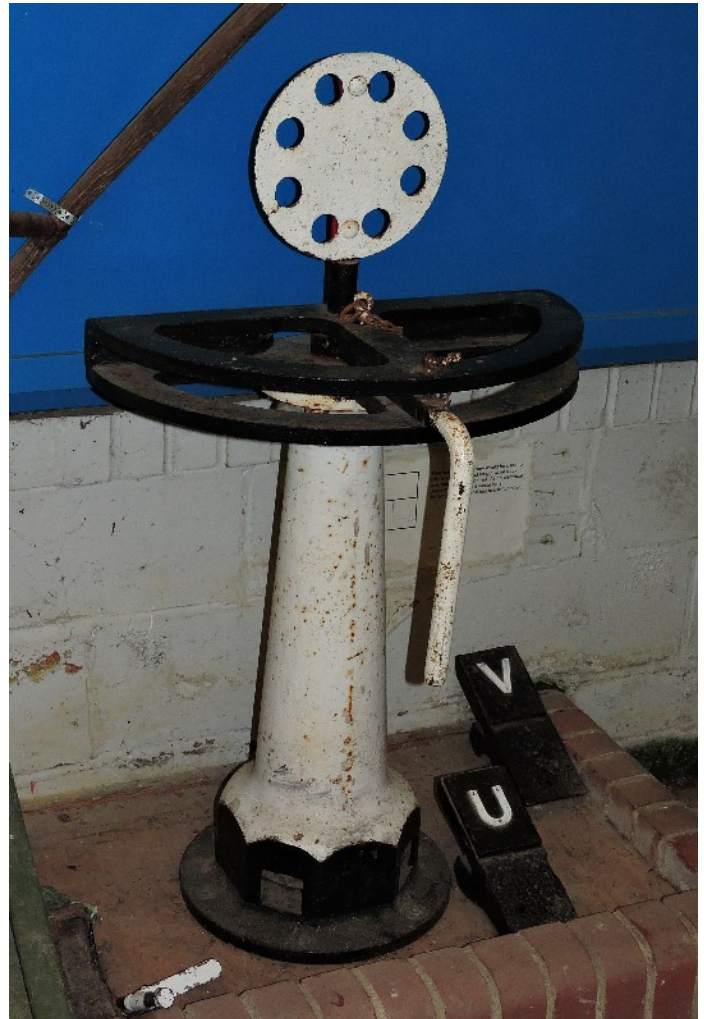
Figure 7 - FR Disc Capstan at Amberley, March 2015, picture courtesy of Rob Palmer

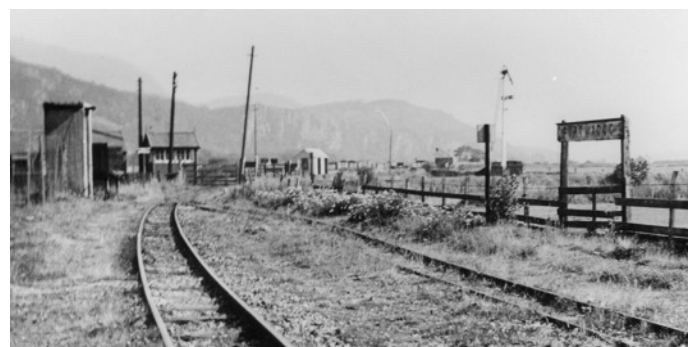
Figure 8 - An LGRP photograph showing the whole Portmadoc New complex - Contemporary with Figure 9 (Arch3356 - 1936)

Figure 8 dates from 1936, and shews that the water tank has been recovered from Portmadoc New but the 'stage'

Notably in Figure 8 the large single-worded stop board has been removed and seemingly replaced with a different board on the other side of the line and nearer the standard gauge (visible between the photographer and the western end of the crossing 'box'). Beyond the crossing, the boards

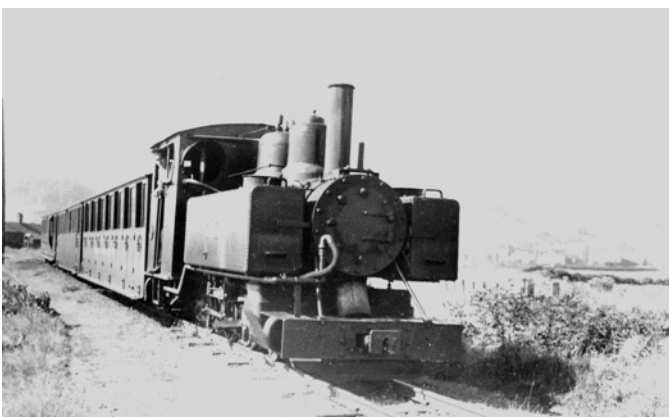
Figure 10 - 590 stands at Portmadoc New with a north-bound train - G.H.W. Clifford 1934 (WHHG34)

dated 1934 a white board on the northern side of the crossing is visible in the rear of a photograph. This 'northern' white board is in approximately the same position as the stop board shown in XD97/459032 and is very much of the same kind as the second 'southern' stop board (Figures 10 and 11). A closer examination of the backgrounds of photographs looking north is in order.

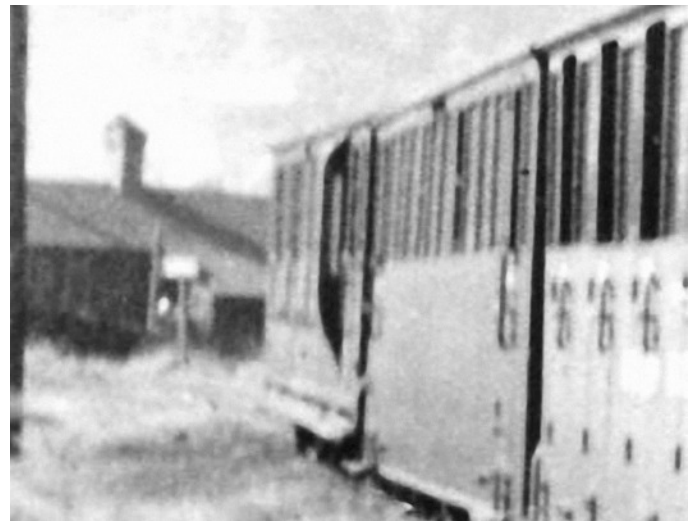
Figure 11 - A somewhat extreme enlargement of a detail from WHHG34

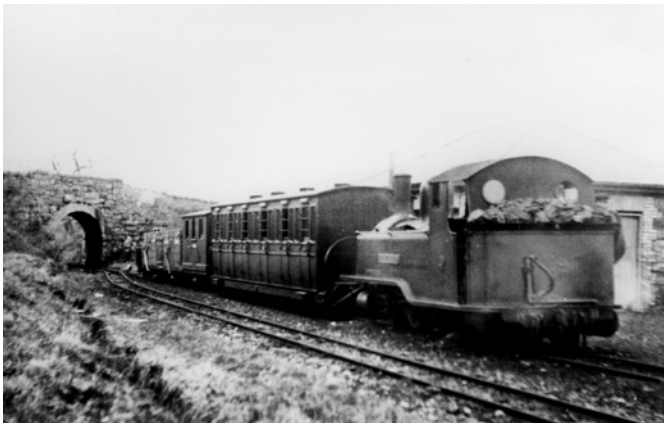
Moel Tryfan with a south-bound mixed passenger and goods train at Waenfawr on 3rd April 1926. In that month there was only one daily departure from Dinas - at 12:45 - Ken Nunn (WHHG 8)

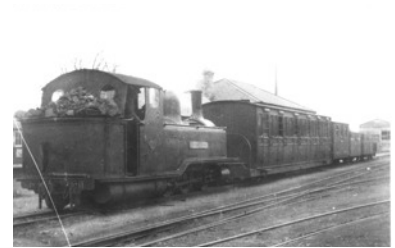
Ken Nunn's three photographs showing the same train before its departure from Dinas.
