WELSH HIGHLAND HERITAGE

Issue No. 72

BEDDGELERT WATER TOWER - UPDATE

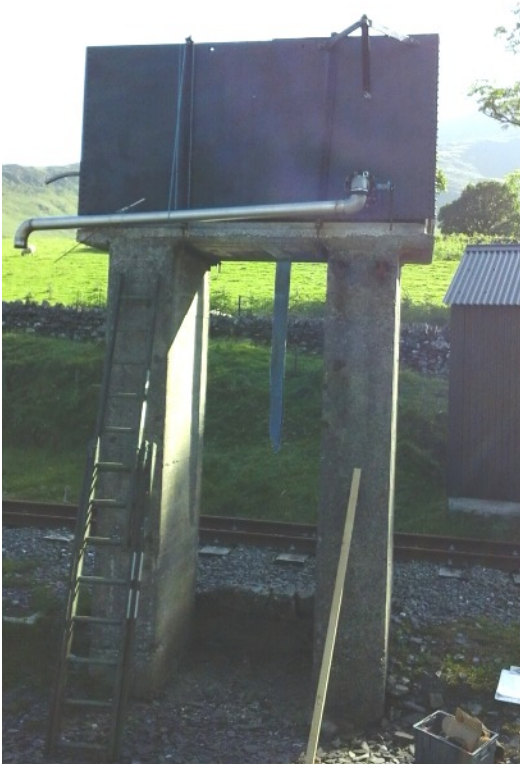
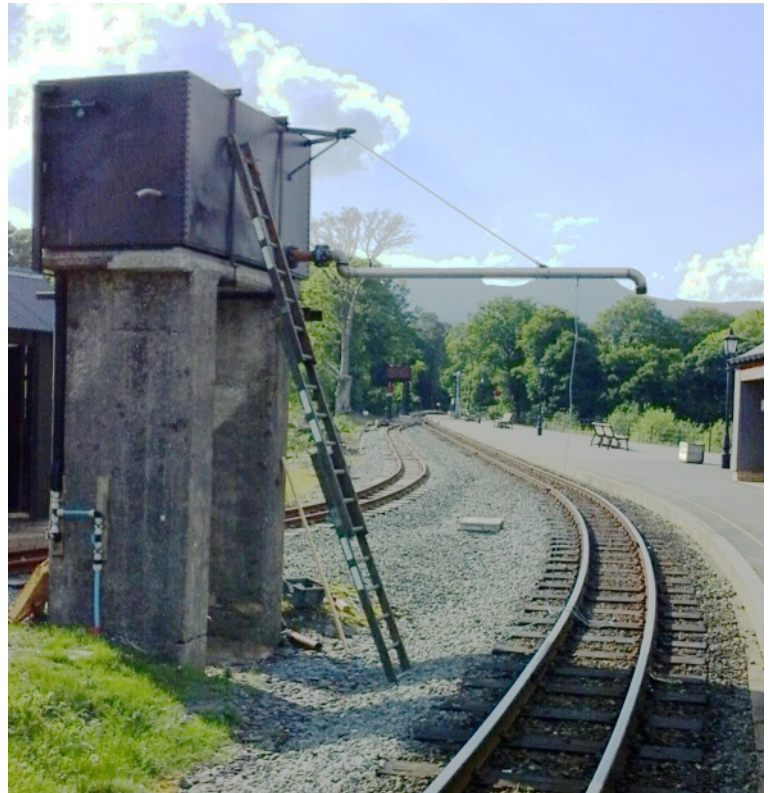
During the winter months, I was busy making the bits and pieces necessary to complete the installation of the Main Line side delivery. Because the track is now further away from the tank than the original layout, the new delivery pipe must swing out from the tank. This requires a water tight swivel joint. The water crane at the Down end of Beddgelert Station has one.

Cedric Lodge has been working hard to complete the Heritage water tower installation at Beddgelert. He has provided these notes on his progress to date.

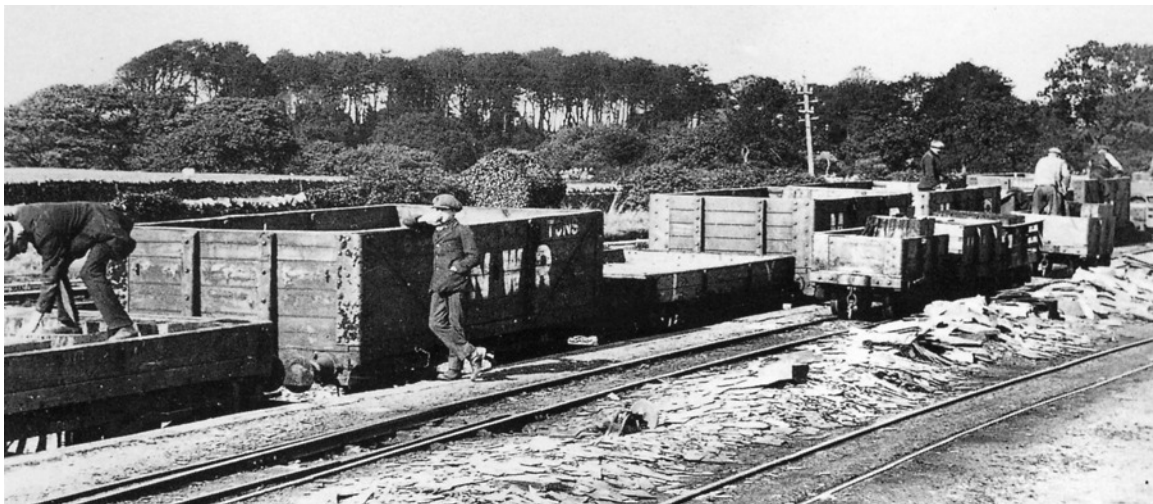
The 'Dinas Junction Problem' identified by the NWNCR in their evidence to Parliament in 1885. Note the 'hive of industry' and the considerable pile of broken slate to the right of the narrow gauge wagons. Admittedly this photo was actually taken in the 1920's but little had probably changed since the 1880's. - L&GRP 2461 (WHHG 20)

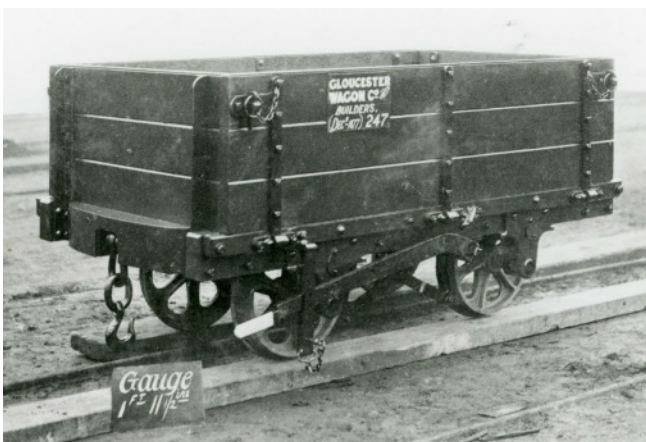
Figure 1 (left) - Maker's photograph of a drop-sided wooden slate wagon for the NWN GR - Gloucestershire Records Office D 4791/16/1

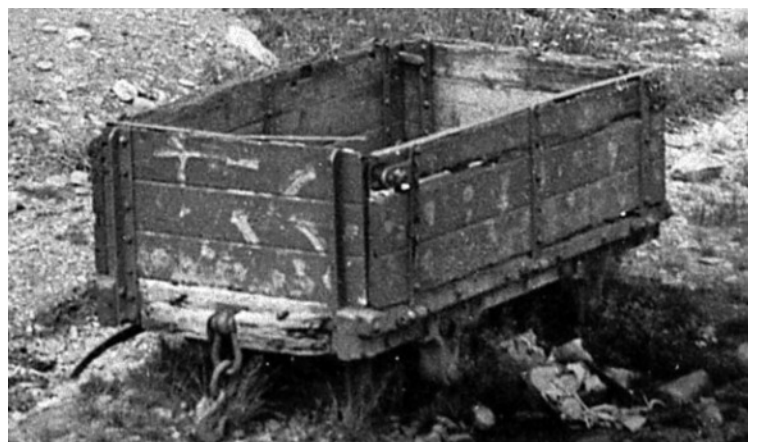
Figure 2 (right) - For many years, apparently, a single wagon lay out of use at Rhyd Ddu/Snowdon Station on the NWN GR. This wagon can be seen in a number of photographs - figure 2 is an enlargement from a Francis Bedford (the Company, not the man who died in 1894) image of 1897 published by Catherall and Pritchard as their C&P 2754 (WHR 66). '2754' is a Bedford Archive image number which aids us in dating the photograph via the Francis Bedford Archive at Birmingham Library. Apart from minor detail in the axle box support area, the comparison between the two images is compelling. Wagons of this type have not been in any other NWN GR or WHR photographic location, unless any reader can advise to the contrary!

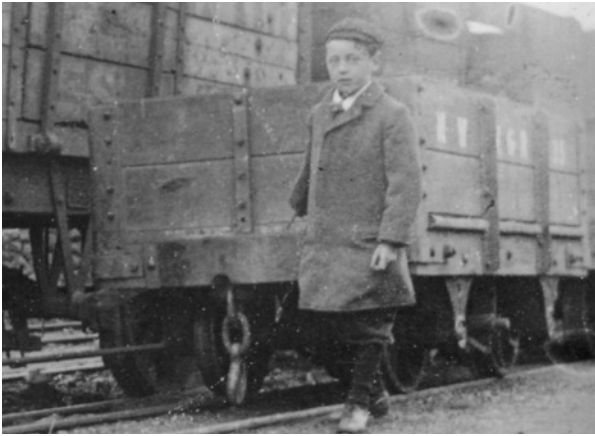
Figure 3 (left) allows an early glimpse of a 'standard' NWNGR wooden slate wagon (no. 35) seen alongside standard gauge stock at Dinas Junction - Gwynedd Archives.

The most numerous box wagons to one single design appear to be the type shown in figures 3 and 4. Boyd has suggested⁽⁵⁾ that the angle irons supporting the sides of the wagons were indications of repairs, replacing the original wooden battens damaged in service. However, all of the photographs of these vehicles show these angle irons and there is no indication that they were ever fitted with wooden battens. Indeed, wagons that were fitted with such battens were to be seen right up until the final days of the WHR/FR.

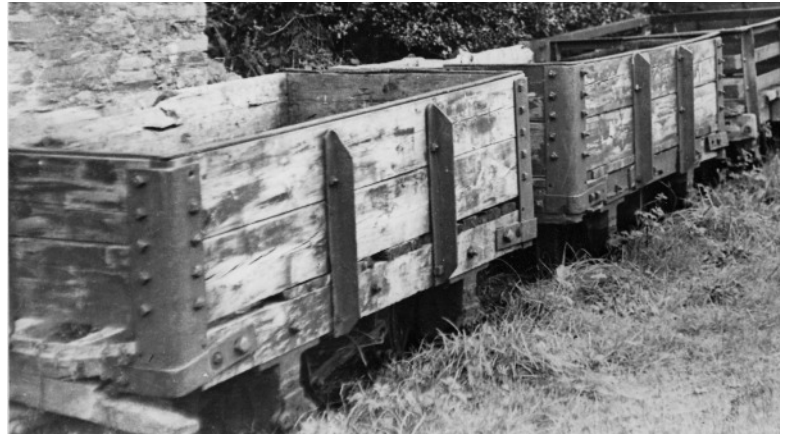
Figure 4 (right) is an enlargement from a photo showing a line of derelict stock at Dinas Junction after the closure of the WHR - WHR77. These two photos show some of the wagons' construction detail and also show there to have been at least two different designs of axle box support adopted by their manufacturer(s?).

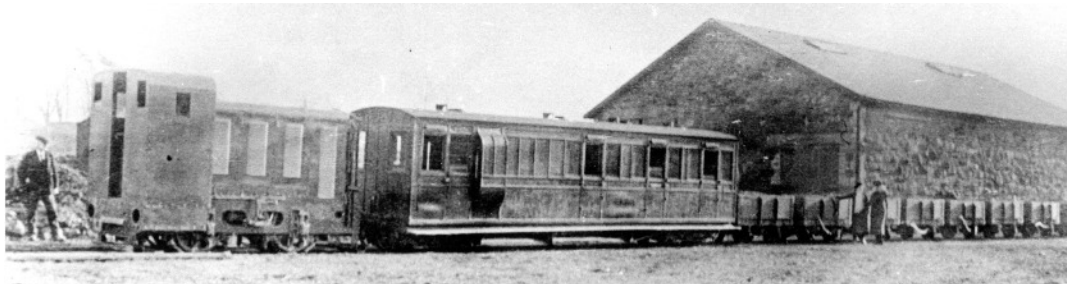
Figure 5 - A rake of at least 8 of the 'standard' NWNGR box slate wagons attached to the rear of one of the Pickering brake composites at Dinas Junction during the trial of a Dick, Kerr petrol-electric locomotive in early 1917 - WHR132

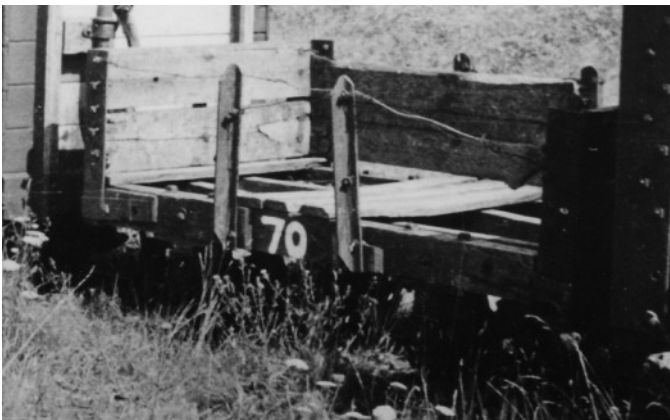
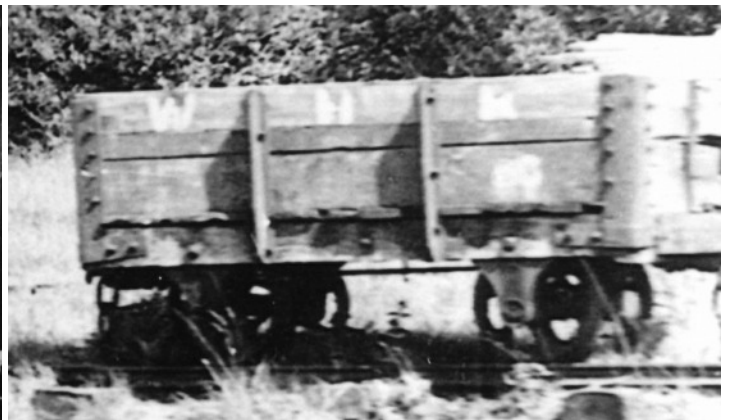
Figure 6 (left) - H.F. Wheeler August 1935 (Wheeler 14/12) - and Figure 7 (right) - H.C. Casserley July 1941 - show examples of NWNGR 'standard' wooden slate wagons in various stages of decay.

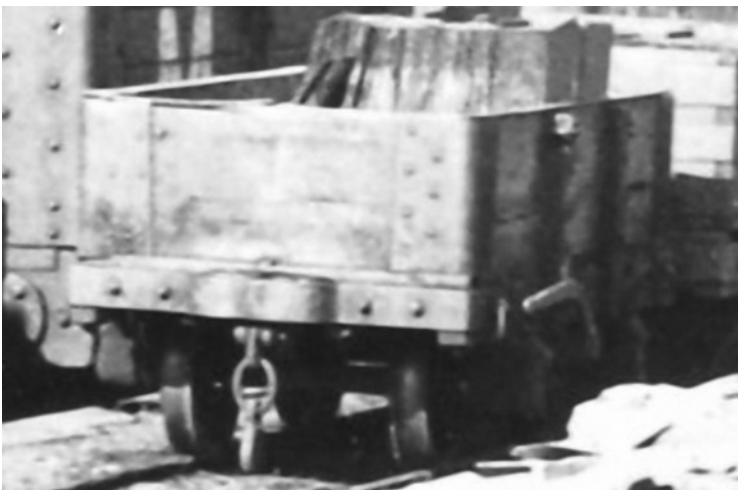
Figure 8 (left) and Figure 9 (right) are enlargements from WHHG20 (reproduced in full on page 4) and demonstrate two distinct designs of wooden box wagon, each unlike the 'standard' design of wagons shown in figures 3 to 7 above.

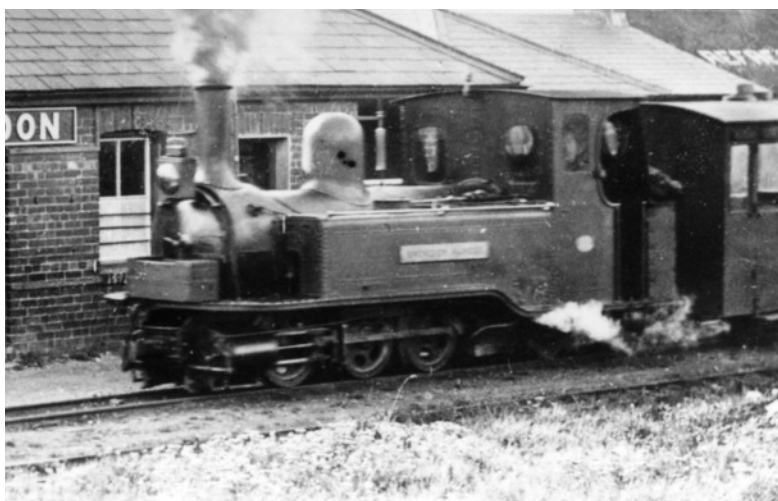
Figure 3 (left) - *Snowdon Ranger* arrives at Snowdon Station ca.1914. Note that the sand-boxes are no longer present.

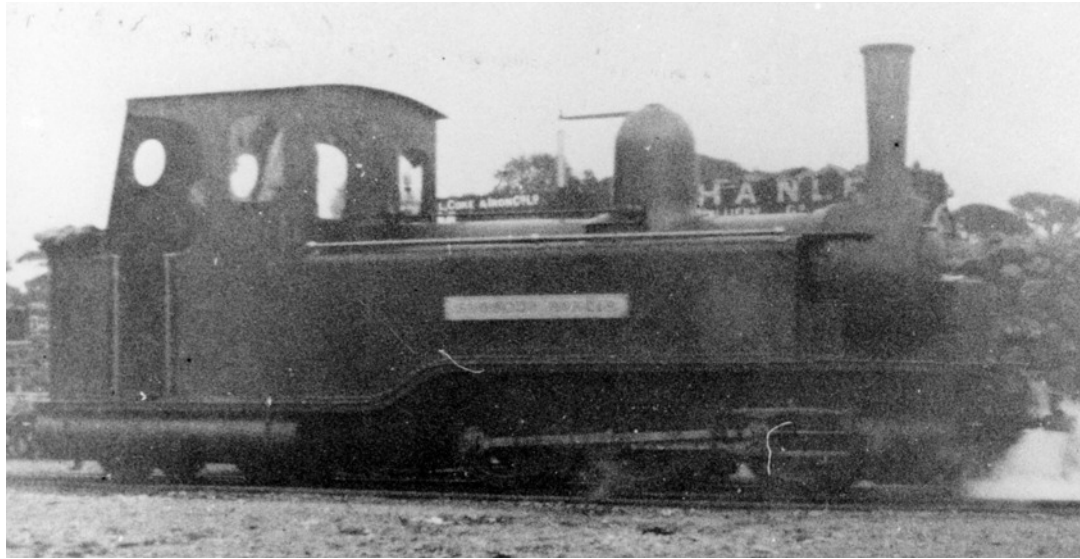
Figure 1 (left) - Maker's photo of *Snowdon Ranger* 1875 - note sand-box arrangement, whistle location and maker's plate. (WHR16)

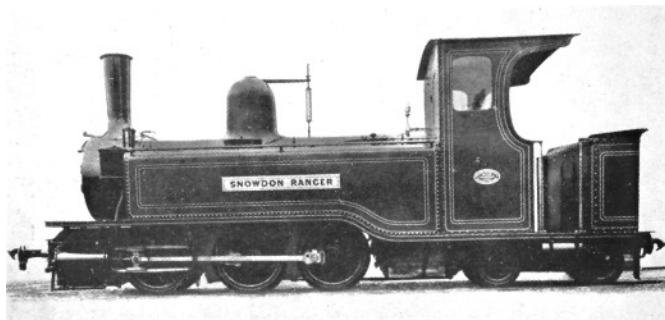
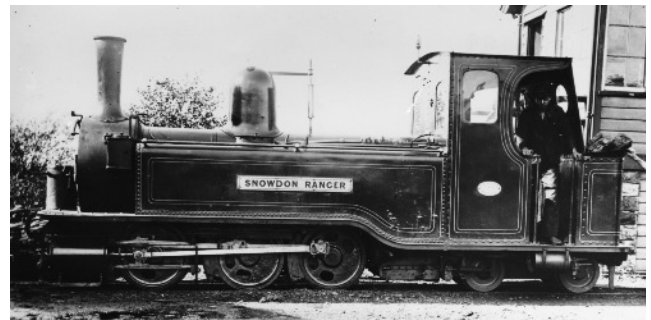
Figure 2 (right) - *Snowdon Ranger* (after re-boiling) at Dinas Junction ca.1908. Note the relocated whistle and changes to the maker's plate but the same arrangement of sand-boxes and operating linkages - Locomotive Publishing Co. No. 5633 (later 77872)
