### WELSH HIGHLAND 2.00 Issue No. 74 HERITAGE ISSN 1462-1371

## NWNGR Wagons - Slate Stock (2)

# Peter Liddell's Photo Analysis

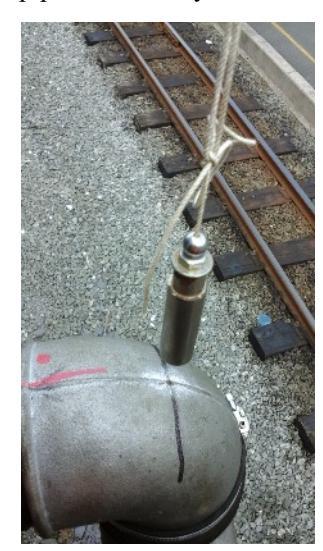
The 'missing' photograph showing the centre pop and plum bob.

I mentioned in an earlier article (in *WHH* 72) the significance of locating the centre of rotation of the swivel unit. I have since found the photo shown here, which shows the centre pop on the top elbow which marks the centre of rotation, and the plumb bob close to it. The position of the centre pop was established in the workshop, and was vital to the setting of the swivel unit.

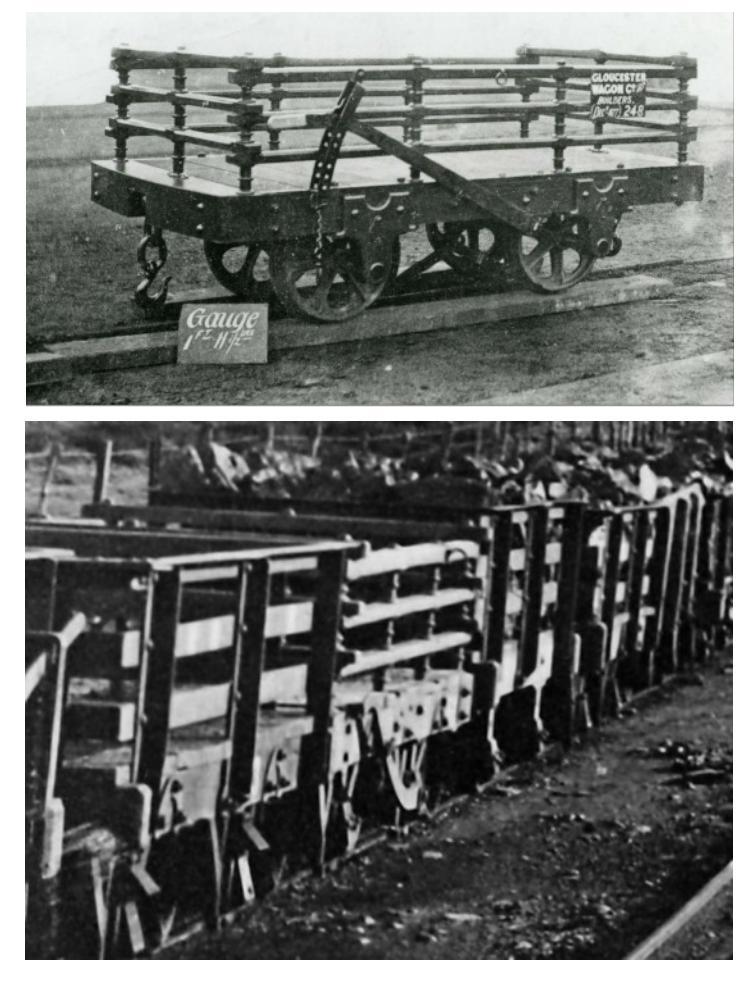
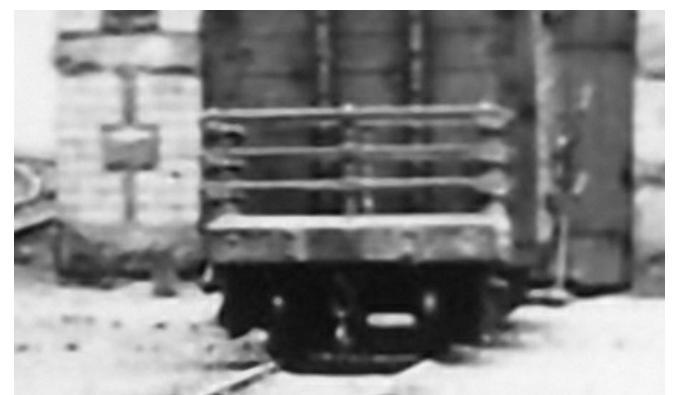
Three photographs showing NWNGR wooden open-slat slate wagons. Photo 1 (above left) is an 1877 Gloucester Wagon Co. Photo of a vehicle purported to have been built for the NWNGR (Gloucestershire Records Office D 4791/16/1). Photo 2 (above), taken at Dinas Junction (Symons Gems of Wales - 1893 - WHR 98), and Photo 3 (left), taken at Bryngwyn (Keylock Collection - WHR 109), show wooden wagons in service.

This manufacturer's photograph is reproduced here (photo no. 1) along with a pair of other images (photos no. 2 and 3) showing wooden slate wagons in service on the NWNGR. A simple assessment of these photographs indicates one clear difference between these wagons – those in service appear significantly wider than that shown in the manufacturer's photo. The inservice vehicles, it would seem, were of a very similar width, if not the same width, as the 'iron crate' wagons, although as will be discussed later this comparison demands care!

Photo 2 shows distinct differences in the buffing arrangements and photo 3 indicates similarly significant differences in the wheel-mounting arrangement. Both indicate a much greater 'overhang' of the solebars relative to the wheels when compared to the manufacturer's photo.

However, the wagons in the latter two images differ significantly from the maker's photo, particularly with respect to the vehicles' width. The wagon in the background of the second photo was one of the 'ridge top' covered vans operated by the NWNGR and the wooden slate wagon in the photo to the left is conveniently sandwiched between two of the 'iron crate' wagons and the similarity of their overall widths is striking.

The long rake of wagons to be seen in the un-cropped version of the third photograph shows just one more of the wooden-slatted slate wagons.

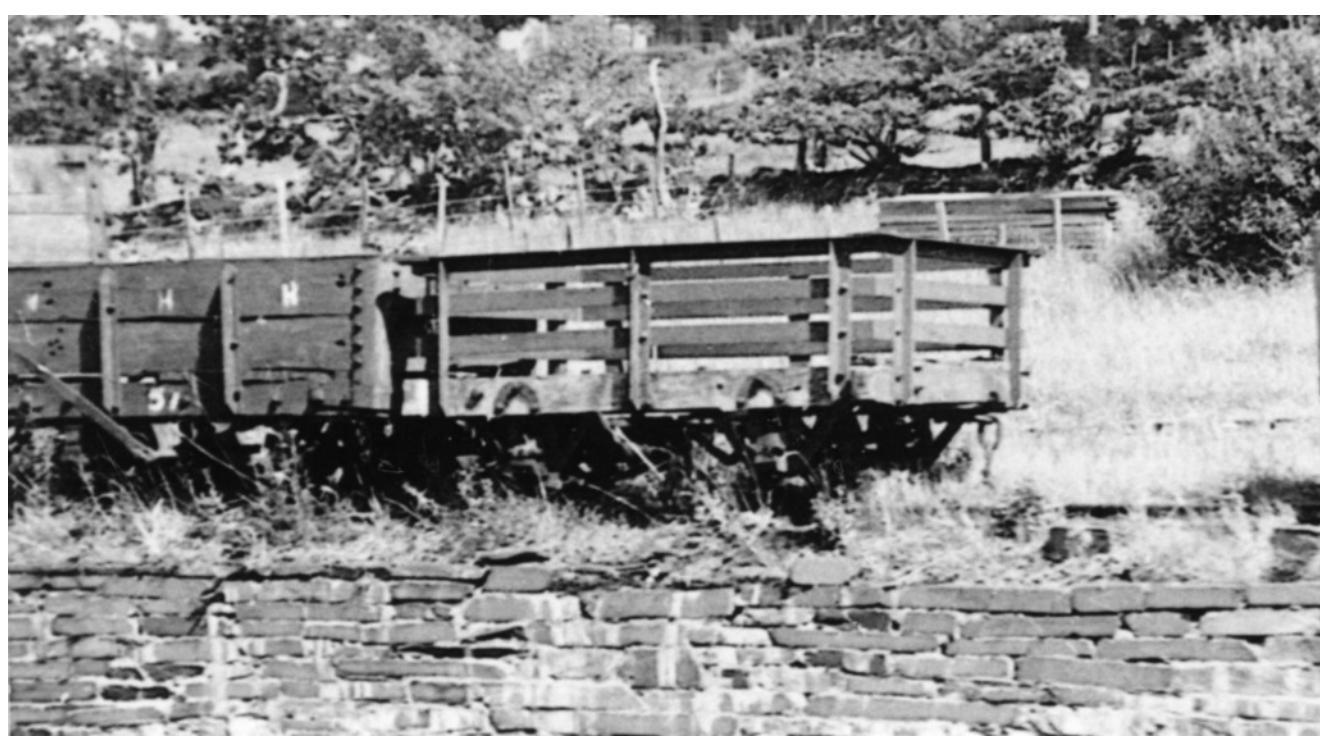
Photo 4) - One of the ex-NWNGR 'Iron Crate' slate wagons photographed at Dinas Junction after the closure of the Welsh Highland. A number of key features are readily identifiable in this image although the level of detail discernible below the solebars is disappointing - H.C. Casserley - 18<sup>th</sup> July 1941.

Photographs 4 and 5 give us two views of examples of the large wagons. Photo 5 is particularly useful as it offers an almost direct end-on view with a number of scaling aids clearly visible.

Whilst reiterating my warnings regarding significant differences between individual slate wagons, I have developed the following drawings from analysis of these two photographs. The end detail has been taken from photograph 5 but close examination will show that there were differences in this end detail between these two wagons.

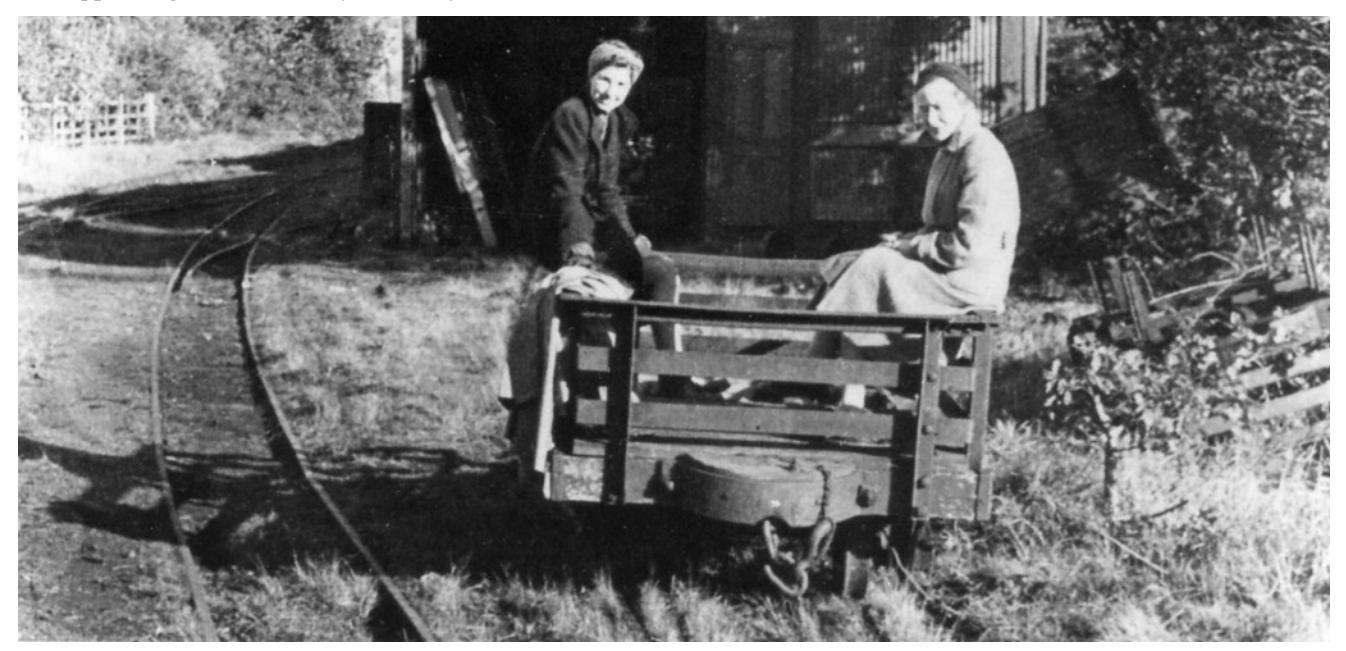
Photo 5) - Another of the crate wagons at Dinas after closure of the WHR. This photograph offers a clear, almost 'square-on', end view of the wagon with significant scaling 'clues'. Detailed structural differences will be noted if the above two photographs are compared carefully. - J.F. Bolton - 1941

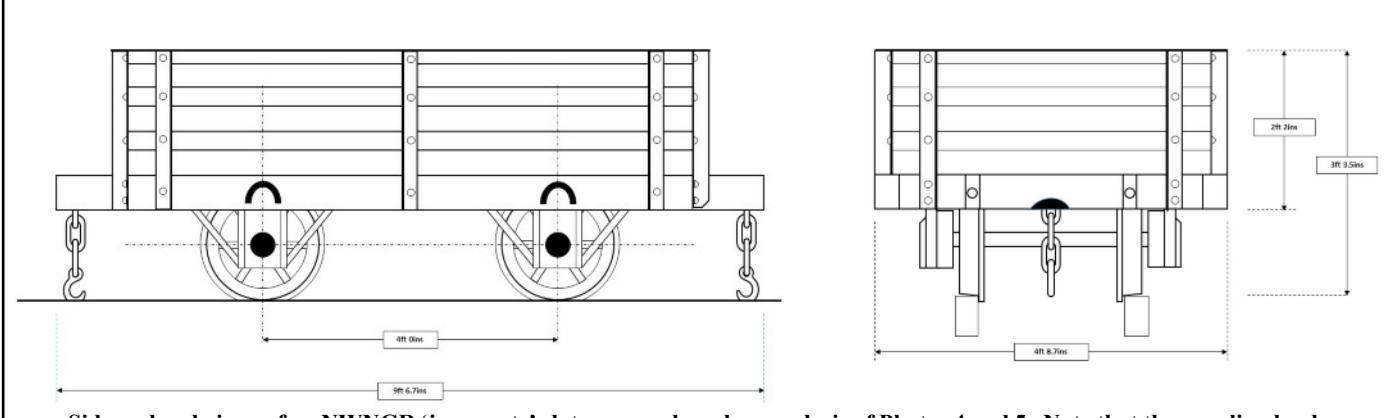
Side and end views of an NWNGR 'iron crate' slate wagon, based on analysis of Photos 4 and 5. Note that the coupling hooks naturally hung below the height of the rail tops. Photo 5 shows the provisions adopted to prevent the couplings fouling the track work when not in use.

The dumb buffers fitted to these wagons were large curved fittings - I have indicated semi-circular buffers but here again there are differences to be seen between wagons. Whether the differences were deliberate or the result of 'wear-and-tear' is a matter for speculation.

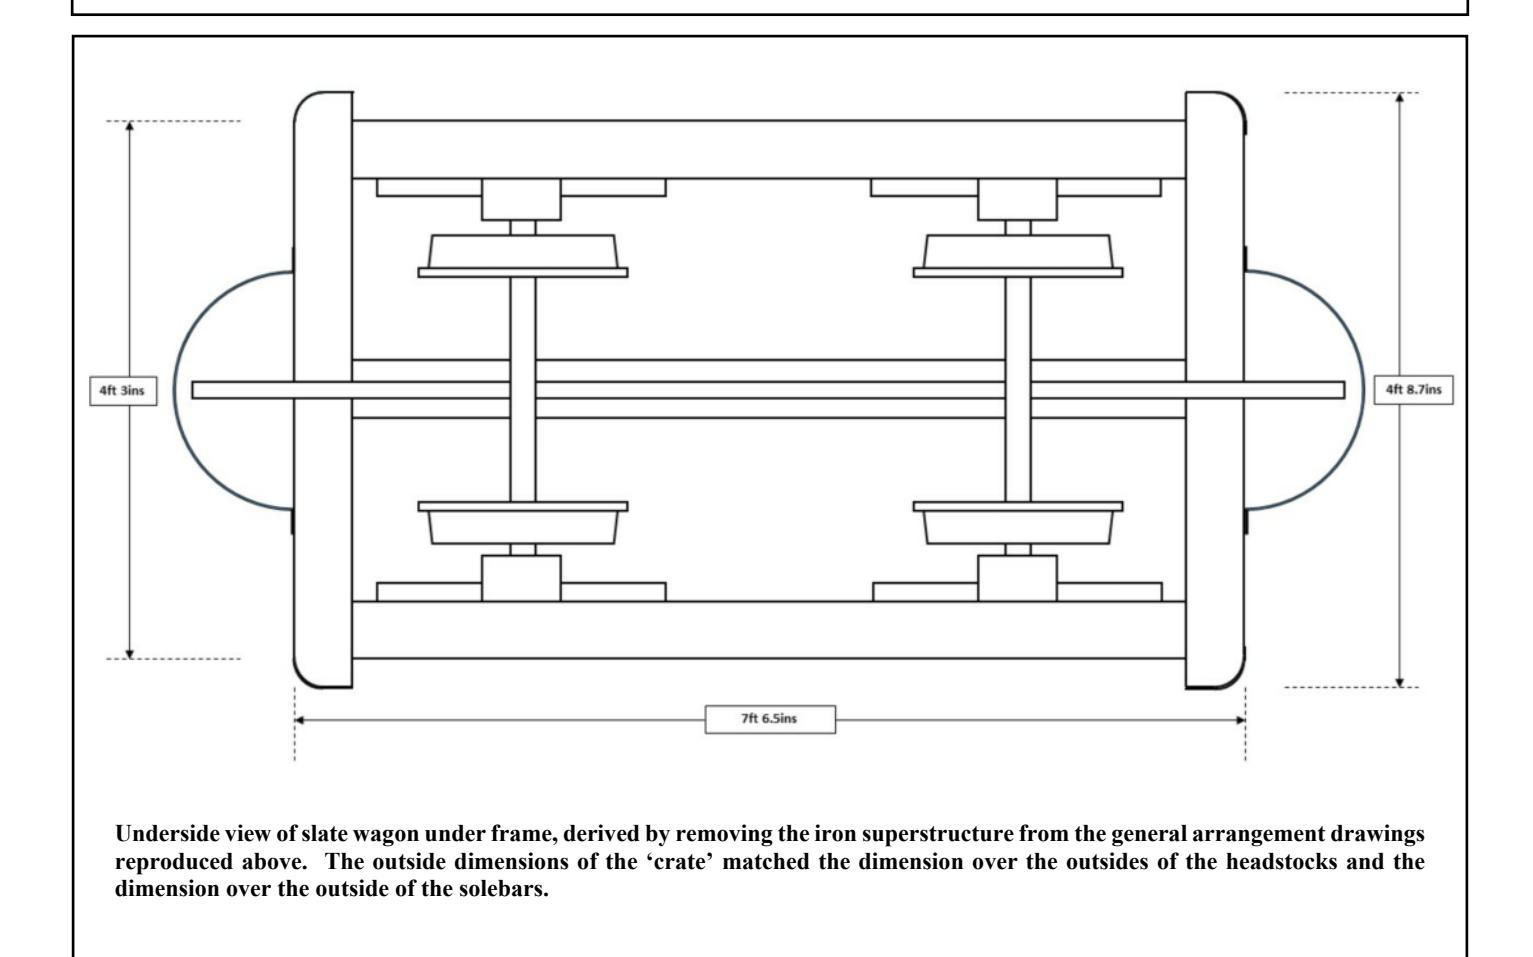
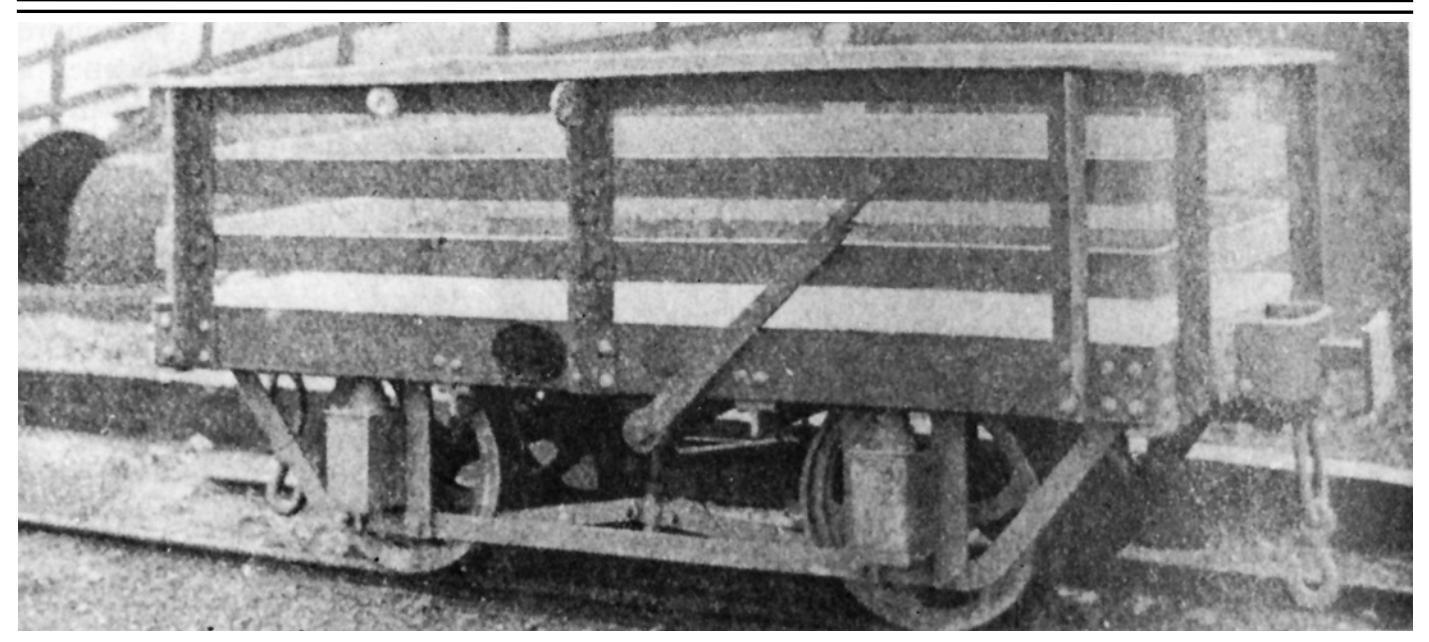
Photo 6 - This picture has often been published as indicative of NWNGR slate wagon practice. It is apparent that the wagon shown here differs significantly from those that we can see in surviving images. For example the 'crate' fitted here is noticeably narrower than on the vehicles in the previous photos. An initial assessment suggests that the vehicle here was between 1ft and 1ft 3.75ins narrower than that shown in the drawings above, i.e. its width was between 3ft 5ins and approximately 3ft 9ins. The couplings are fundamentally different and the chassis structure is quite distinct, showing what appears to be a metal under frame. Despite there being no photographs of wagons in this precise form on either the NWNGR or WHR, chassis such as these can be seen in some of the 'demolition' train photos taken in the early 1940s.

There is a much-published photograph (photo no. 6) which appears to be a manufacturer's photo of a slate wagon apparently built to NWNGR requirements. Precisely who the manufacturer was or where the photo was taken appears not to have been recorded. Whilst superficially similar to the crate wagons discussed above there were a number of obvious differences. First, the wagon superstructure was noticeably narrower than those discussed above and second the metal superstructure appeared to be mounted on a metal underframe. The buffing arrangements were distinctly different, as was the structural arrangement providing a longitudinal link between the axle box supports.

I am not aware of any photographs that show wagons like this in either NWNGR or WHR service. However, chassis of this type can be seen in photographs of the demolition trains in the early 1940s where at least a couple of these wagon underframes appear to have survived as 'flats'. However, photograph 7 does show what is clearly an NWNGR slate wagon (no. 88) of the narrower design and fitted with sprung buffers but in this photograph the metal superstructure is tied to a wooden underframe. The axle boxes mounted directly below the solebars are clearly visible.

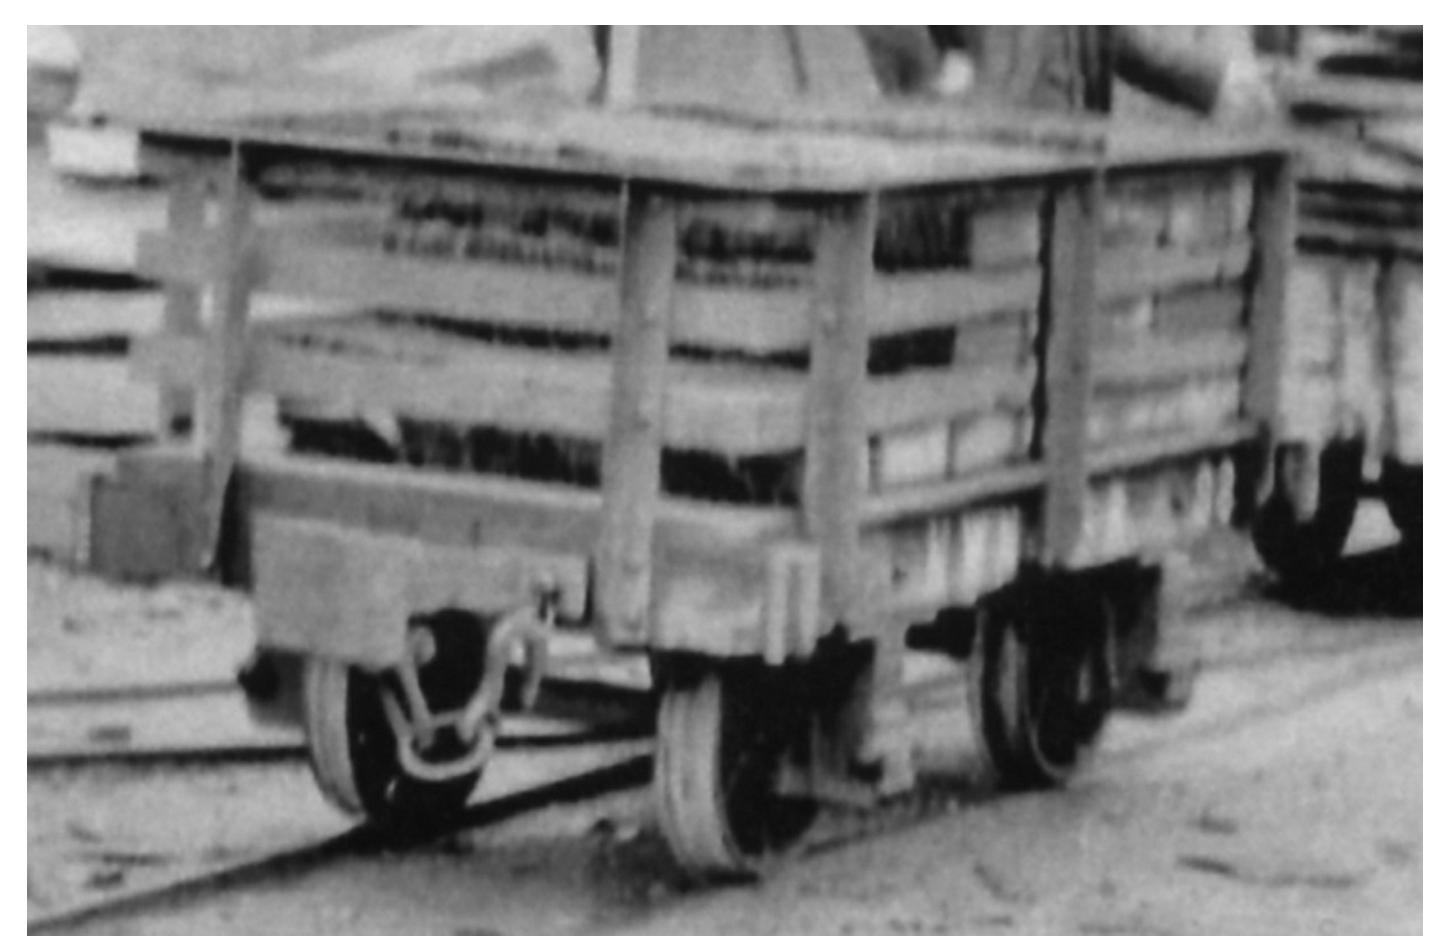
Photo 7 - NWNGR slate wagon no. 88 at the mills below Hafod y Wern Quarry, Bettws Garmon. The photograph was taken at some time between the summer of 1890 and March 1898 - Dafydd Walter Dafis collection/Gwynfor Pierce Jones.

This vehicle seems to comprise the same narrower body seen in photo 6 together with similar buffers, although the chain detail does not match. However, the body here is fitted to a wooden under frame and there is evidence of there being some packing between the iron work and the solebars, although this is not as pronounced as in the case of no. 120 (photo 8).

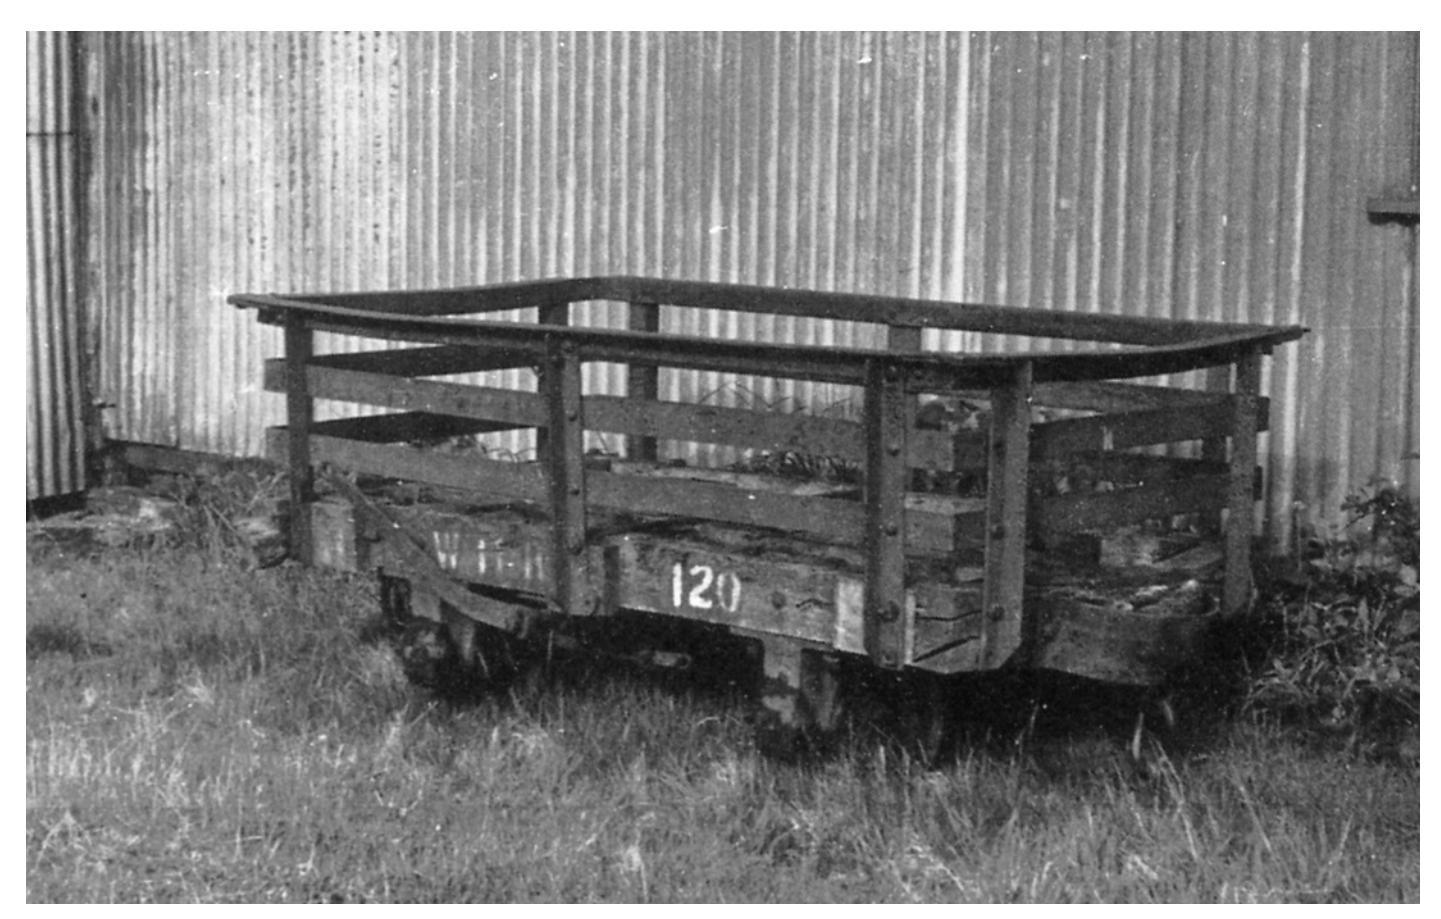
Photo 8) - Another post-closure view, this time showing one of the 'crate' structures attached to a narrower underframe. Note that the axle-boxes are mounted directly below the solebars and that there are packing pieces between the vertical side brackets and the solebars to make up for the difference in underframe width. - F.M. Gates - 1939 (WHR 53)

Photo 8 below shows a dilapidated slate wagon outside the Dinas carriage shed in 1939. This photo clearly shows the mismatch between the iron crate and the solebars and, indicative of reuse of the crate on a 'spare' underframe, it also shows the packing used to restore the original solebar width. There is no evidence of any packing at the ends of the vehicle, indicating that the frames used in these rebuilds, or at least in this rebuild, had the correct dimension over the headstocks. The photograph also begs the question as to whether the clearly visible wagon number (120) was inherited from the original vehicle whose sub-frame this was.

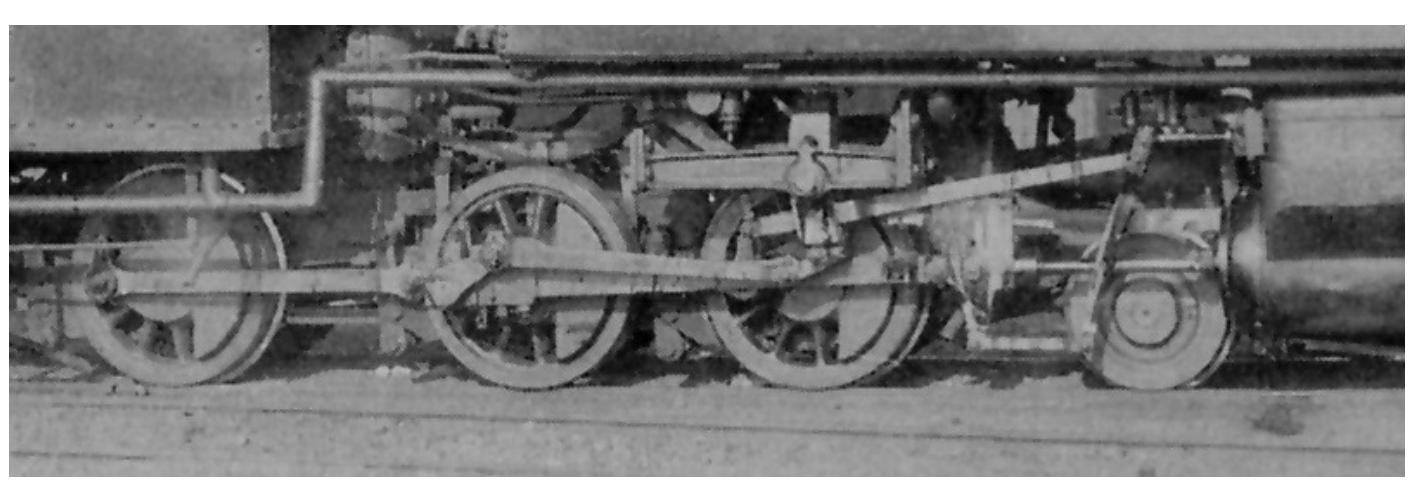
Detail from a photo by A W Croughton taken at Dinas Junction in 1924 (photo WHR 216)

We can judge the position of the die block most reliably by looking at the radius bar and, if we have a clear view of the valve gear, and if we remember our 'rule of thumb', we can immediately determine which gear the crew had selected.

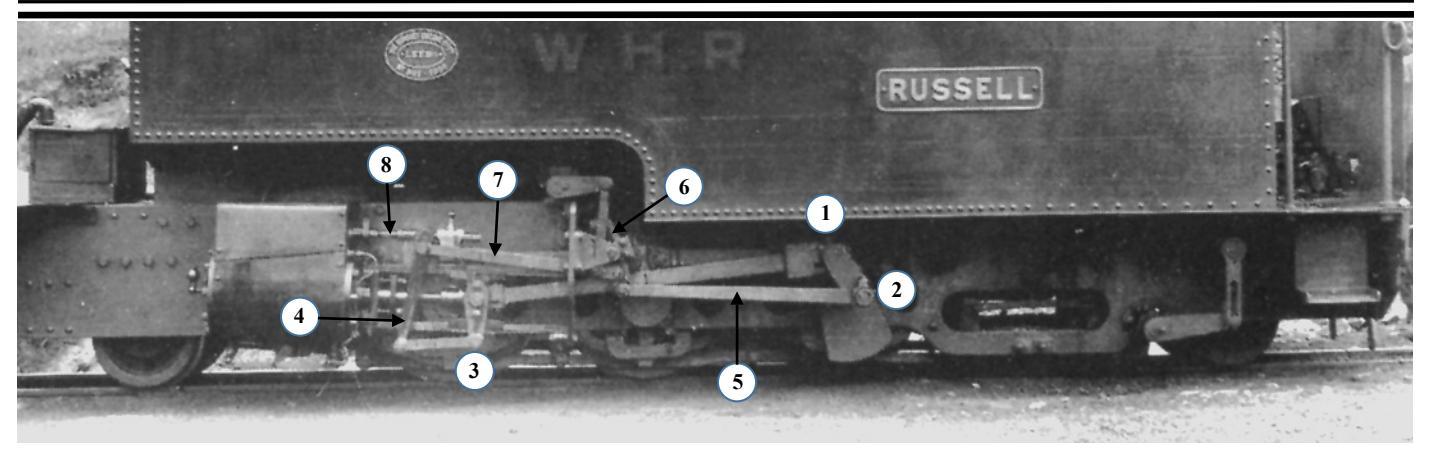
A detail from photo WHR 158 - LPC 1659 - taken at Beddgelert in 1928

In an earlier note in this series (*WHH* 63 p 12), I used the valve gear settings on the *Baldwin* to determine that the locomotive was actually reversing when the photograph under discussion was taken. Walschaerts valve gear can be useful when analysing photographs as it reveals so much information regarding the locomotive. However, care has to be exercised when doing this so this time I thought it would be useful to highlight a few technical essentials to aid analysis. I will try not to produce a detailed technical thesis!

The key factor to be considered when determining forward and reverse gear settings is the relationship between the main and the eccentric cranks. We have already noted that there is an angle of 90 degrees between these cranks but individual designers can choose whether they wish their eccentric cranks to 'lead' or to 'follow' the main cranks as the wheels rotate. There are simple 'rules of thumb' which allow gear position to be recognised. With outside admission valves, if the eccentric 'leads' the main crank then in forward gear the die block would be in the lower half of the expansion link. If the eccentric 'follows' the main crank then in forward gear the die block would be in the upper half of the expansion link.
